Access Compliance Report
Public Rights-of-Way
(Curb Ramps)

Intersection ID: 12052	Main Street: E_17TH_ST	Cross Street: PEGRAM_ST	Location: W
ADA ID: D9B30C700147	Ramp Type: PerpDiag	Initial Pass/Fail: Fail	Overall Compliance: No	Severity Score: 35

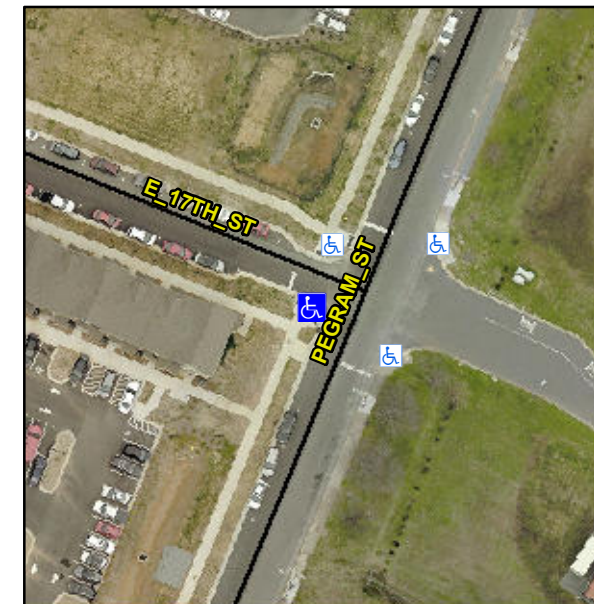
Not Found, R304.5.1

Compliance	Description	Data	Compliance	Description	Data
N/A	Ramp Length (in)	68.0	Yes	Ramp Slope (%)	6.6
No	Ramp Width (in)	24.0	Yes	Ramp XSlope (%)	0.2
N/A	Flare Type LT	N/A	N/A	Flare Type RT	N/A
N/A	Flare Slope LT (%)	N/A	N/A	Flare Slope RT (%)	N/A
N/A	Flare Traversable LT?	N/A	N/A	Flare Traversable RT?	N/A
N/A	Landing Length (in)	N/A	N/A	DWS Provided?	N/A
N/A	Landing Width (in)	N/A	N/A	DWS Contrast?	N/A
N/A	Landing Slope (%)	N/A	N/A	DWS Length (in)	N/A
N/A	Landing X Slope (%)	N/A	N/A	DWS Full Width?	N/A
N/A	Landing Curb? (Y/N)	N/A	N/A	DWS Offset (in)	N/A
N/A	Shared Landing?	N/A			
N/A	Gutter Ponding?	N/A	N/A	Gutter Slope (%)	N/A
N/A	Gutter Lip Ht (in)	N/A	N/A	Gutter X Slope (%)	N/A
N/A	Painted X Walk1?	No	N/A	Painted X Walk2?	No
	X Walk 1 Direction	To SE		X Walk 2 Direction	To NE
N/A	X Walk 1 Width (in)	N/A	N/A	X Walk 2 Width (in)	N/A
	X Walk 1 Slope (%)	4.6		X Walk 2 Slope (%)	2.1
	X Walk 1 X Slope (%)	2.3		X Walk 2 X Slope (%)	1.7

N/A	Ramp inside XWalk1?	N/A	N/A	Ramp inside XWalk2?	N/A
	Road Slope (%)	2.3	N/A	Clear Space?	N/A
	Road X Slope (%)	2.3	N/A	Clear Space to XWalk (in)	N/A
N/A	Any Obstructions?	N/A	N/A	Storm Grate/Utility Hazard?	N/A
	Obstruction Type			Storm Grate/Utility Type	
N/A					N/A
			Yes	Surface Condition? (G/P)	Good

Remove & Replace Curb Ramp With Two New Directional Ramps or Equivalent.
