Access Compliance Report
Public Rights-of-Way
(Curb Ramps)

Intersection ID: 29271 **Main Street:** IRON_BRIGADE_LN **Cross Street:** LAKOTA_CT **Location:** W

ADA ID: DBEA3E02709C **Ramp Type:** PerpDiag **Initial Pass/Fail:** Fail **Overall Compliance:** No **Severity Score:** 8.75

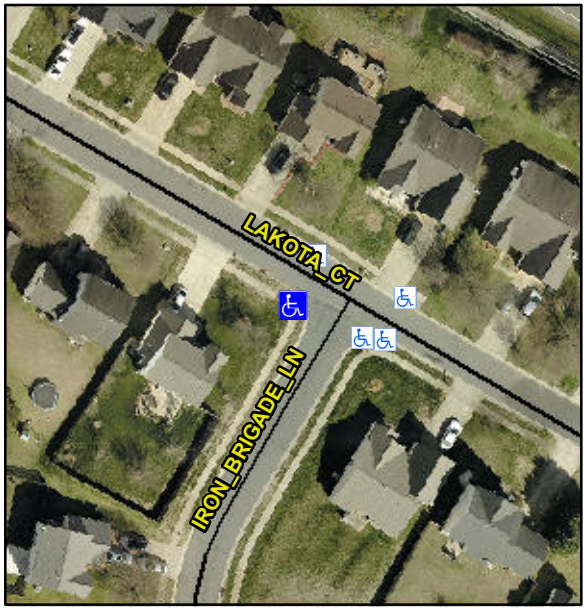
Not Found, R304.5.1

Compliance	Description	Data	Compliance	Description	Data
N/A	Ramp Length (in)	46.0	Yes	Ramp Slope (%)	6.6
No	Ramp Width (in)	38.0	Yes	Ramp XSlope (%)	1.3
N/A	Flare Type LT	N/A	N/A	Flare Type RT	N/A
N/A	Flare Slope LT (%)	N/A	N/A	Flare Slope RT (%)	N/A
N/A	Flare Traversable LT?	N/A	N/A	Flare Traversable RT?	N/A
N/A	Landing Length (in)	N/A	N/A	DWS Provided?	N/A
N/A	Landing Width (in)	N/A	N/A	DWS Contrast?	N/A
N/A	Landing Slope (%)	N/A	N/A	DWS Length (in)	N/A
N/A	Landing X Slope (%)	N/A	N/A	DWS Full Width?	N/A
N/A	Landing Curb? (Y/N)	N/A	N/A	DWS Offset (in)	N/A
N/A	Shared Landing?	N/A			
N/A	Gutter Ponding?	N/A	N/A	Gutter Slope (%)	N/A
N/A	Gutter Lip Ht (in)	N/A	N/A	Gutter X Slope (%)	N/A
N/A	Painted X Walk1?	No	N/A	Painted X Walk2?	No
	X Walk 1 Direction	To S		X Walk 2 Direction	To N
N/A	X Walk 1 Width (in)	N/A	N/A	X Walk 2 Width (in)	N/A
	X Walk 1 Slope (%)	2.6		X Walk 2 Slope (%)	2.5
	X Walk 1 X Slope (%)	2.1		X Walk 2 X Slope (%)	2.3

Remove & Replace Curb Ramp With Two New Directional Ramps or Equivalent.
