Access Compliance Report
Public Rights-of-Way
(Curb Ramps)

Intersection ID: 4095	Main Street: MALLARD_COVE_CT	Cross Street: MALLARD_RIDGE_DR	Location:	SE
ADA ID: DC0B641CA101	Ramp Type: Perp	Initial Pass/Fail: Fail	Overall Compliance: No	Severity Score: 8.75

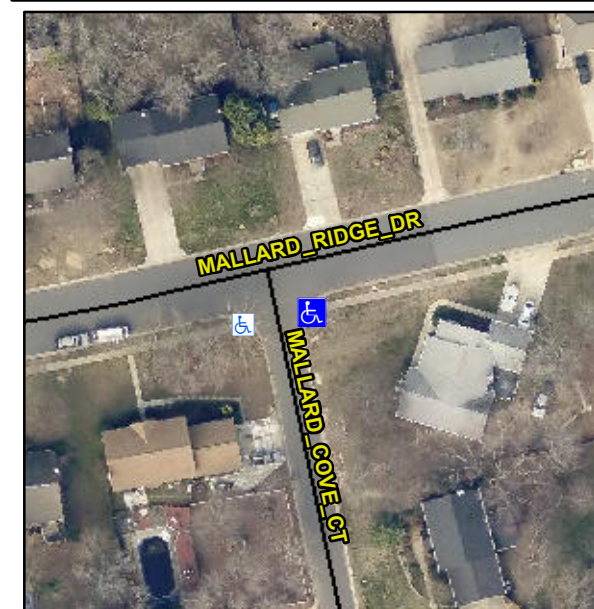
Not Found, R304.5.1

Compliance	Description	Data	Compliance	Description	Data
N/A	Ramp Length (in)	60.0	Yes	Ramp Slope (%)	7.7
No	Ramp Width (in)	47.5	Yes	Ramp XSlope (%)	0.3
N/A	Flare Type LT	N/A	N/A	Flare Type RT	N/A
N/A	Flare Slope LT (%)	N/A	N/A	Flare Slope RT (%)	N/A
N/A	Flare Traversable LT?	N/A	N/A	Flare Traversable RT?	N/A
N/A	Landing Length (in)	N/A	N/A	DWS Provided?	N/A
N/A	Landing Width (in)	N/A	N/A	DWS Contrast?	N/A
N/A	Landing Slope (%)	N/A	N/A	DWS Length (in)	N/A
N/A	Landing X Slope (%)	N/A	N/A	DWS Full Width?	N/A
N/A	Landing Curb? (Y/N)	N/A	N/A	DWS Offset (in)	N/A
N/A	Shared Landing?	N/A			
N/A	Gutter Ponding?	N/A	N/A	Gutter Slope (%)	N/A
N/A	Gutter Lip Ht (in)	N/A	N/A	Gutter X Slope (%)	N/A
N/A	Painted X Walk1?	No	N/A	Painted X Walk2?	N/A
	X Walk 1 Direction	To W		X Walk 2 Direction	N/A
N/A	X Walk 1 Width (in)	N/A	N/A	X Walk 2 Width (in)	N/A
	X Walk 1 Slope (%)	4.7		X Walk 2 Slope (%)	N/A
	X Walk 1 X Slope (%)	3.8		X Walk 2 X Slope (%)	N/A

Remove & Replace Entire Ramp.
