# Access Compliance Report
# Public Rights-of-Way
# (Curb Ramps)

| Intersection ID: 10024974 | Main Street: DIXIE_RIVER_RD | Cross Street: N/A | Location: N |
| ADA ID: DC967C041F27 | Ramp Type: Perp | Initial Pass/Fail: Fail | Overall Compliance: No | Severity Score: 21.25 |

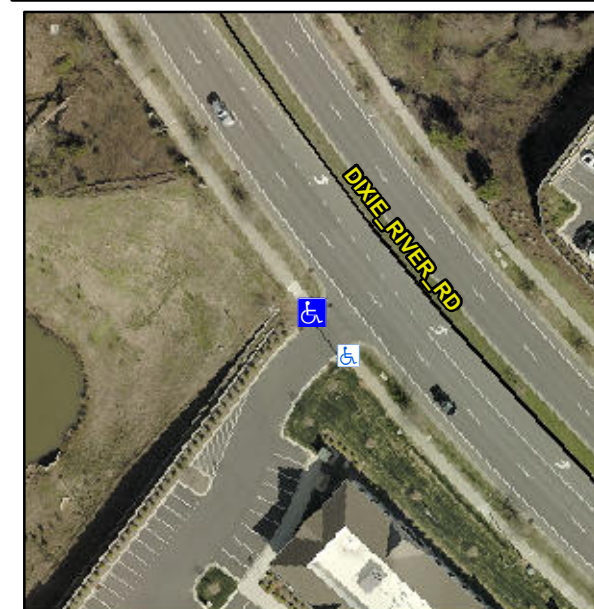
**Not Found,  R304.5.1, R304.2.2**

| Compliance | Description | Data | Compliance | Description | Data |
|---|---|---|---|---|---|
| N/A | Ramp Length (in) | 62.0 | No | Ramp Slope (%) | 9.0 |
| No | Ramp Width (in) | 46.0 | Yes | Ramp XSlope (%) | 1.0 |

**Remove & Replace Entire Ramp.**
