# Access Compliance Report
Public Rights-of-Way
(Curb Ramps)

Intersection ID: N/A	Main Street: SHARON RD	Cross Street: HAZELTON DR	Location:	SW
ADA ID: DD4F8D4383E9	Ramp Type: Directional1	Initial Pass/Fail: Pass	Overall Compliance: No	Severity Score: 12.5

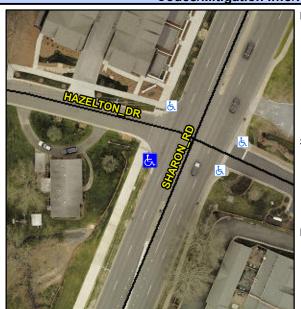
R302.7.2, R304.5.4, R304.5.3

Compliance	Description	Data	Compliance	Description	Data
N/A	Ramp Length (in)	164.0	Yes	Grade Break?	Yes
Yes	Ramp Width (in)	120.0	Yes	Grade Break Slope (%)	2.6
Yes	Ramp Slope (%)	1.6	Yes	Grade Break XSlope (%)	0.3
Yes	Ramp XSlope (%)	0.7			
Yes	Flare Type LT	N/A	Yes	Flare Type RT	N/A
N/A	Flare Slope LT (%)	N/A	N/A	Flare Slope RT (%)	N/A
N/A	Flare Traversable LT?	No	N/A	Flare Traversable RT?	No
Yes	Landing Length (in)	60.0	Yes	DWS Provided?	Yes
Yes	Landing Width (in)	120.0	Yes	DWS Contrast?	Yes
Yes	Landing Slope (%)	1.1	Yes	DWS Length (in)	24.0
Yes	Landing X Slope (%)	0.0	Yes	DWS Full Width?	Yes
N/A	Landing Curb? (Y/N)	N/A	Yes	DWS Offset LT (in)	1.0
N/A	Shared Landing?	No	Yes	DWS Offset RT (in)	58.0
Yes	Gutter Ponding?	No	No	Gutter Slope (%)	9.5
No	Gutter Lip Ht (in)	0.5	No	Gutter X Slope (%)	4.0
N/A	Painted X Walk1?	No		Road Slope (%)	1.3
	X Walk 1 Direction	To N		Road X Slope (%)	4.0
	X Walk 1 Width (in)	N/A		Clear Space?	Yes

X Walk 1 Slope (%)	1.3	N/A	Clear Space to XWalk (in)	N/A
	X Walk 1 X Slope (%)	4.0	Yes	Storm Grate/Utility Hazard?	No
N/A	Ramp inside XWalk1?	N/A		Storm Grate/Utility Type	
Yes	Any Obstructions?	No			N/A
	Obstruction Type		Yes	Surface Condition? (G/P)	Good
			N/A	Yes Curb Slope (%)	1.9

Remove & Replace Gutter.
