Access Compliance Report
Public Rights-of-Way
(Curb Ramps)

Intersection ID: N/A	Main Street: DURANT_BV	Cross Street: KESSLER_DR	Location:	N
ADA ID: DD980CCDD5C9	Ramp Type: PerpDiag	Initial Pass/Fail: Fail	Overall Compliance: No	Severity Score: 42.5

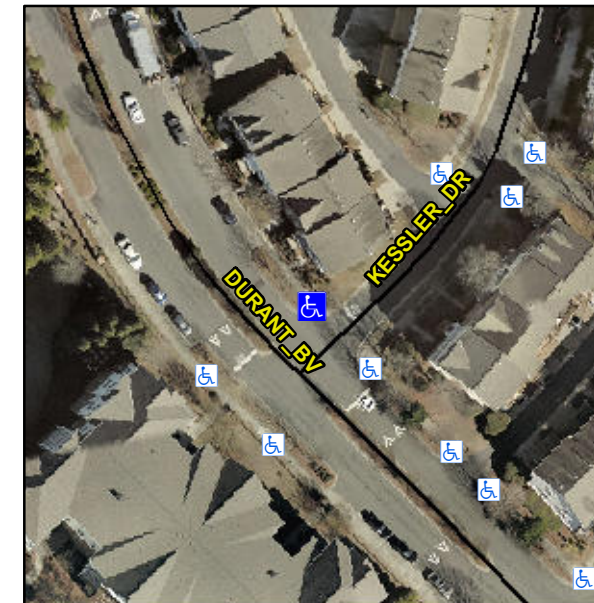
Not Found, R304.5.1, R304.5.3

Compliance	Description	Data	Compliance	Description	Data
N/A	Ramp Length (in)	119.0	Yes	Ramp Slope (%)	5.8
No	Ramp Width (in)	33.0	No	Ramp XSlope (%)	7.9
N/A	Flare Type LT	N/A	N/A	Flare Type RT	N/A
N/A	Flare Slope LT (%)	N/A	N/A	Flare Slope RT (%)	N/A
N/A	Flare Traversable LT?	N/A	N/A	Flare Traversable RT?	N/A
N/A	Landing Length (in)	N/A	N/A	DWS Provided?	N/A
N/A	Landing Width (in)	N/A	N/A	DWS Contrast?	N/A
N/A	Landing Slope (%)	N/A	N/A	DWS Length (in)	N/A
N/A	Landing X Slope (%)	N/A	N/A	DWS Full Width?	N/A
N/A	Landing Curb? (Y/N)	N/A	N/A	DWS Offset (in)	N/A
N/A	Shared Landing?	N/A			
N/A	Gutter Ponding?	N/A	N/A	Gutter Slope (%)	N/A
N/A	Gutter Lip Ht (in)	N/A	N/A	Gutter X Slope (%)	N/A
N/A	Painted X Walk1?	No	N/A	Painted X Walk2?	No
	X Walk 1 Direction	To SW		X Walk 2 Direction	To SE
N/A	X Walk 1 Width (in)	N/A	N/A	X Walk 2 Width (in)	N/A
	X Walk 1 Slope (%)	2.7		X Walk 2 Slope (%)	6.3
	X Walk 1 X Slope (%)	5.3		X Walk 2 X Slope (%)	0.5

Remove & Replace Curb Ramp With Two New Directional Ramps or Equivalent.
