Access Compliance Report

# Public Rights-of-Way
(Curb Ramps)

Intersection ID: 24156	Main Street: ARBOR_GLEN_LN	Cross Street: ARBOR_POINTE_DR	Location:	W
ADA ID: DE43670F21CD	Ramp Type: PerpDiag	Initial Pass/Fail: Fail	Overall Compliance: No	Severity Score: 25

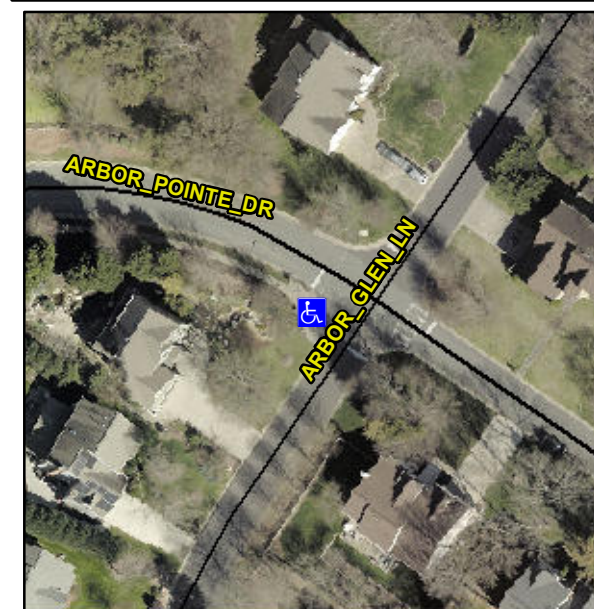
Not Found, R304.2.2

Compliance	Description	Data	Compliance	Description	Data
N/A	Ramp Length (in)	99.0	No	Ramp Slope (%)	14.9
Yes	Ramp Width (in)	48.0	Yes	Ramp XSlope (%)	1.4
N/A	Flare Type LT	N/A	N/A	Flare Type RT	N/A
N/A	Flare Slope LT (%)	N/A	N/A	Flare Slope RT (%)	N/A
N/A	Flare Traversable LT?	N/A	N/A	Flare Traversable RT?	N/A
N/A	Landing Length (in)	N/A	N/A	DWS Provided?	N/A
N/A	Landing Width (in)	N/A	N/A	DWS Contrast?	N/A
N/A	Landing Slope (%)	N/A	N/A	DWS Length (in)	N/A
N/A	Landing X Slope (%)	N/A	N/A	DWS Full Width?	N/A
N/A	Landing Curb? (Y/N)	N/A	N/A	DWS Offset (in)	N/A
N/A	Shared Landing?	N/A			
N/A	Gutter Ponding?	N/A	N/A	Gutter Slope (%)	N/A
N/A	Gutter Lip Ht (in)	N/A	N/A	Gutter X Slope (%)	N/A
N/A	Painted X Walk1?	No	N/A	Painted X Walk2?	No
	X Walk 1 Direction	To SE		X Walk 2 Direction	To NE
N/A	X Walk 1 Width (in)	N/A	N/A	X Walk 2 Width (in)	N/A
	X Walk 1 Slope (%)	0.3		X Walk 2 Slope (%)	5.5
	X Walk 1 X Slope (%)	4.2		X Walk 2 X Slope (%)	0.2

Remove & Replace Curb Ramp With Two New Directional Ramps or Equivalent.
