Access Compliance Report
Public Rights-of-Way
(Curb Ramps)

Intersection ID: 11480	**Main Street:** N_CEDAR_ST	**Cross Street:** W_5TH_ST	**Location:** W
ADA ID: DE5C06C2CE80	**Ramp Type:** PerpDiag	**Initial Pass/Fail:** Fail	**Overall Compliance:** No **Severity Score:** 13.75

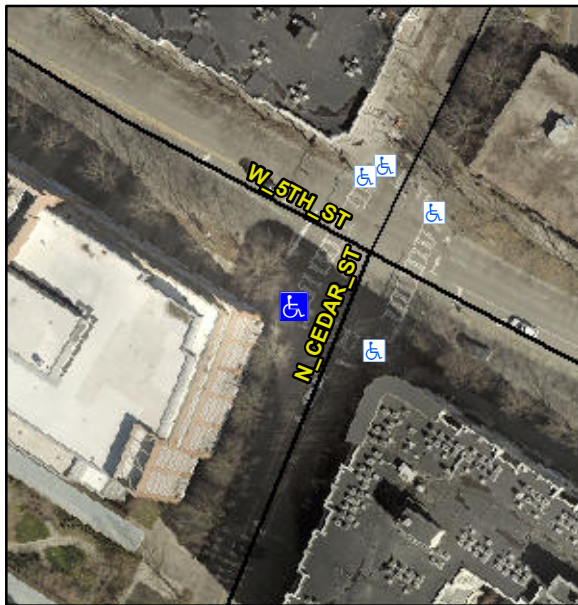
N/A

R304.2.2, R304.5.3

Compliance	Description	Data	Compliance	Description	Data
N/A	Ramp Length (in)	84.0	No	Ramp Slope (%)	10.0
Yes	Ramp Width (in)	48.0	No	Ramp XSlope (%)	3.0
N/A	Flare Type LT	N/A	N/A	Flare Type RT	N/A
N/A	Flare Slope LT (%)	N/A	N/A	Flare Slope RT (%)	N/A
N/A	Flare Traversable LT?	N/A	N/A	Flare Traversable RT?	N/A
N/A	Landing Length (in)	N/A	N/A	DWS Provided?	N/A
N/A	Landing Width (in)	N/A	N/A	DWS Contrast?	N/A
N/A	Landing Slope (%)	N/A	N/A	DWS Length (in)	N/A
N/A	Landing X Slope (%)	N/A	N/A	DWS Full Width?	N/A
N/A	Landing Curb? (Y/N)	N/A	N/A	DWS Offset (in)	N/A
N/A	Shared Landing?	N/A			
N/A	Gutter Ponding?	N/A	N/A	Gutter Slope (%)	N/A
N/A	Gutter Lip Ht (in)	N/A	N/A	Gutter X Slope (%)	N/A
N/A	Painted X Walk1?	Yes	N/A	Painted X Walk2?	Yes
	X Walk 1 Direction	To SE		X Walk 2 Direction	To NE
N/A	X Walk 1 Width (in)	106.0	N/A	X Walk 2 Width (in)	105.0
	X Walk 1 Slope (%)	5.3		X Walk 2 Slope (%)	3.1
	X Walk 1 X Slope (%)	1.6		X Walk 2 X Slope (%)	1.8

N/A	Ramp inside XWalk1?	Yes	N/A	Ramp inside XWalk2?	Yes
	Road Slope (%)	1.0	N/A	Clear Space?	N/A
	Road X Slope (%)	3.9	N/A	Clear Space to XWalk (in)	N/A
N/A	Any Obstructions?	N/A	N/A	Storm Grate/Utility Hazard?	N/A
	Obstruction Type			Storm Grate/Utility Type	
		N/A			N/A
			Yes	Surface Condition? (G/P)	Good

Remove & Replace Curb Ramp With Two New Directional Ramps or Equivalent.
