# Access Compliance Report
Public Rights-of-Way
(Curb Ramps)

Intersection ID: 30548	Main Street: SOUTH_BV	Cross Street: CAROLINA_PAVILIION_DR_S	Location:	NE
ADA ID: DE9F464DE9D0	Ramp Type: BlendTrans2	Initial Pass/Fail: Fail	Overall Compliance: No	Severity Score: 21.25

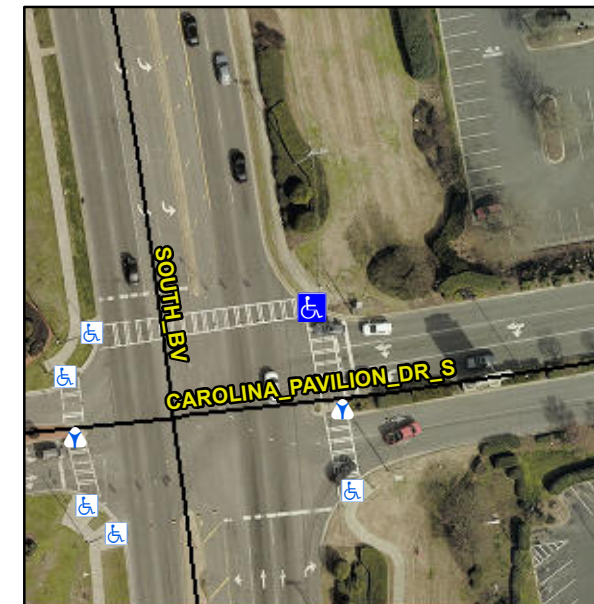
Not Found, R304.5.1, R304.5.3

Compliance	Description	Data	Compliance	Description	Data
N/A	Ramp Length (in)	109.0	Yes	BlendTrans Slope (%)	4.1
No	Ramp Width (in)	47.0	No	BlendTrans XSlope (%)	5.3
N/A	Flare Type LT	N/A	N/A	Flare Type RT	N/A
N/A	Flare Slope LT (%)	N/A	N/A	Flare Slope RT (%)	N/A
N/A	Flare Traversable LT?	N/A	N/A	Flare Traversable RT?	N/A
N/A	Landing Length (in)	N/A	N/A	DWS Provided?	N/A
N/A	Landing Width (in)	N/A	N/A	DWS Contrast?	N/A
N/A	Landing Slope (%)	N/A	N/A	DWS Length (in)	N/A
N/A	Landing X Slope (%)	N/A	N/A	DWS Full Width?	N/A
N/A	Landing Curb? (Y/N)	N/A	N/A	DWS Offset (in)	N/A
N/A	Shared Landing?	N/A			
N/A	Gutter Ponding?	N/A	N/A	Gutter Slope (%)	N/A
N/A	Gutter Lip Ht (in)	N/A	N/A	Gutter X Slope (%)	N/A
N/A	Painted X Walk1?	Yes	N/A	Painted X Walk2?	Yes
	X Walk 1 Direction	To W		X Walk 2 Direction	To S
	X Walk 1 Width (in)	106.0		X Walk 2 Width (in)	134.0
	X Walk 1 Slope (%)	4.9		X Walk 2 Slope (%)	2.8
	X Walk 1 X Slope (%)	0.9		X Walk 2 X Slope (%)	1.0

N/A	Ramp inside XWalk1?	Yes	N/A	Ramp inside XWalk2?	Yes
	Road Slope (%)	1.0		Clear Space?	N/A
	Road X Slope (%)	2.4	N/A	Clear Space to XWalk (in)	N/A
N/A	Any Obstructions?	N/A	N/A	Storm Grate/Utility Hazard?	N/A
	Obstruction Type			Storm Grate/Utility Type	
N/A					N/A
			Yes	Surface Condition? (G/P)	Good
			No	Curb Slope (%)	6.7

Remove & Replace Curb Ramp With Two New Directional Ramps or Equivalent.
