Access Compliance Report
Public Rights-of-Way
(Curb Ramps)

Intersection ID: 48767	**Main Street:** TURNING_WHEEL_DR	**Cross Street:** MINITREE_LN	**Location:** NW
ADA ID: DEB91ACF23C7	**Ramp Type:** PerpDiag	**Initial Pass/Fail:** Fail	**Overall Compliance:** No	**Severity Score:** 8.75

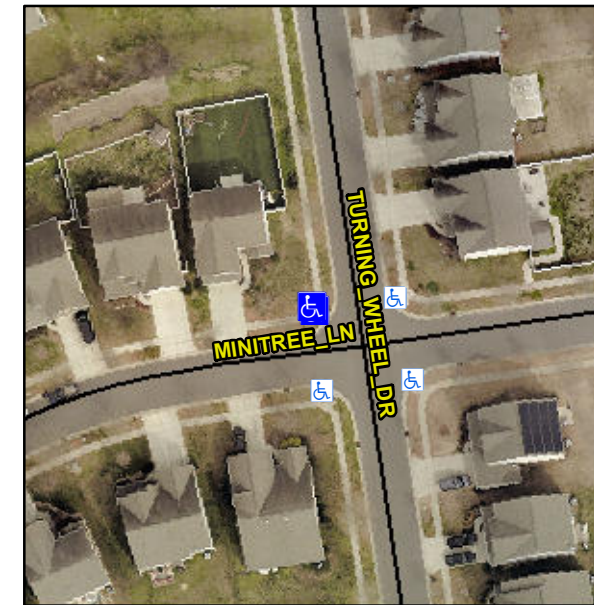
R304.5.1

Compliance	Description	Data	Compliance	Description	Data
N/A	Ramp Length (in)	71.0	Yes	Ramp Slope (%)	6.0
No	Ramp Width (in)	47.5	Yes	Ramp XSlope (%)	0.6
N/A	Flare Type LT	N/A	N/A	Flare Type RT	N/A
N/A	Flare Slope LT (%)	N/A	N/A	Flare Slope RT (%)	N/A
N/A	Flare Traversable LT?	N/A	N/A	Flare Traversable RT?	N/A
N/A	Landing Length (in)	N/A	N/A	DWS Provided?	N/A
N/A	Landing Width (in)	N/A	N/A	DWS Contrast?	N/A
N/A	Landing Slope (%)	N/A	N/A	DWS Length (in)	N/A
N/A	Landing X Slope (%)	N/A	N/A	DWS Full Width?	N/A
N/A	Landing Curb? (Y/N)	N/A	N/A	DWS Offset (in)	N/A
N/A	Shared Landing?	N/A			
N/A	Gutter Ponding?	N/A	N/A	Gutter Slope (%)	N/A
N/A	Gutter Lip Ht (in)	N/A	N/A	Gutter X Slope (%)	N/A
N/A	Painted X Walk1?	No	N/A	Painted X Walk2?	No
	X Walk 1 Direction	To S		X Walk 2 Direction	To E
N/A	X Walk 1 Width (in)	N/A	N/A	X Walk 2 Width (in)	N/A
	X Walk 1 Slope (%)	2.1		X Walk 2 Slope (%)	3.5
	X Walk 1 X Slope (%)	3.2		X Walk 2 X Slope (%)	1.3

Remove & Replace Curb Ramp With Two New Directional Ramps or Equivalent.
