Access Compliance Report
Public Rights-of-Way
(Curb Ramps)

Intersection ID: 10541 **Main Street:** CANTON_PL **Cross Street:** POLK_ST **Location:** S

ADA ID: E03D0598504A **Ramp Type:** Combination2 **Initial Pass/Fail:** Fail **Overall Compliance:** No **Severity Score:** 21.25

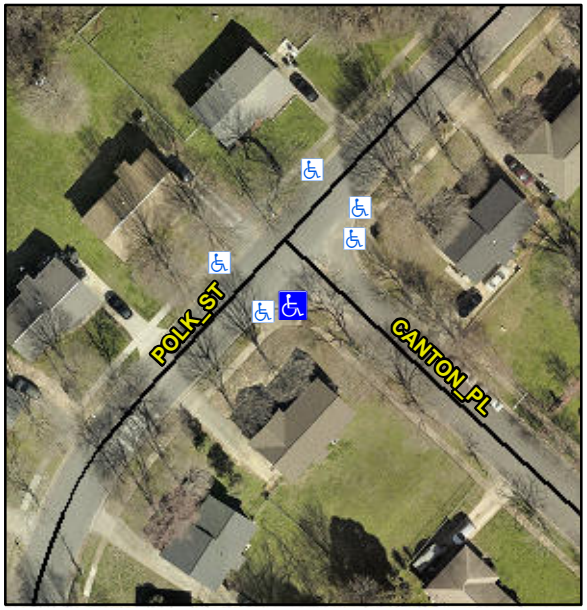
CURB GAP 2.0, LT RP < 5%

Not Found, R304.5.1, R304.5.1, R304.5.3

Remove & Replace Entire Ramp.
