# Access Compliance Report
Public Rights-of-Way
(Curb Ramps)

Intersection ID: 6882	Main Street: STATESVILLE_RD	Cross Street: CINDY_LN	Location:	SE
ADA ID: E185A498E40A	Ramp Type: Perp	Initial Pass/Fail: Fail	Overall Compliance: No	Severity Score: 8.75

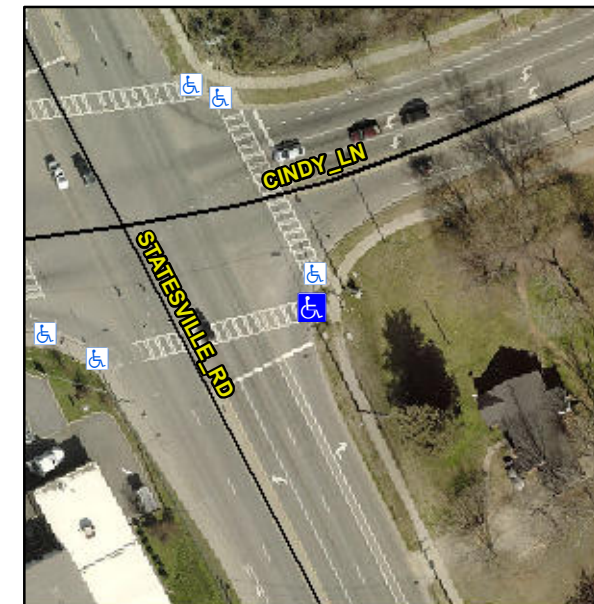
Not Found, R304.5.1

Compliance	Description	Data	Compliance	Description	Data
N/A	Ramp Length (in)	104.5	Yes	Ramp Slope (%)	7.6
No	Ramp Width (in)	36.5	Yes	Ramp XSlope (%)	0.9
N/A	Flare Type LT	N/A	N/A	Flare Type RT	N/A
N/A	Flare Slope LT (%)	N/A	N/A	Flare Slope RT (%)	N/A
N/A	Flare Traversable LT?	N/A	N/A	Flare Traversable RT?	N/A
N/A	Landing Length (in)	N/A	N/A	DWS Provided?	N/A
N/A	Landing Width (in)	N/A	N/A	DWS Contrast?	N/A
N/A	Landing Slope (%)	N/A	N/A	DWS Length (in)	N/A
N/A	Landing X Slope (%)	N/A	N/A	DWS Full Width?	N/A
N/A	Landing Curb? (Y/N)	N/A	N/A	DWS Offset (in)	N/A
N/A	Shared Landing?	N/A			
N/A	Gutter Ponding?	N/A	N/A	Gutter Slope (%)	N/A
N/A	Gutter Lip Ht (in)	N/A	N/A	Gutter X Slope (%)	N/A
N/A	Painted X Walk1?	Yes	N/A	Painted X Walk2?	N/A
	X Walk 1 Direction	To W		X Walk 2 Direction	N/A
N/A	X Walk 1 Width (in)	112.0	N/A	X Walk 2 Width (in)	N/A
	X Walk 1 Slope (%)	0.9		X Walk 2 Slope (%)	N/A
	X Walk 1 X Slope (%)	0.3		X Walk 2 X Slope (%)	N/A

Remove & Replace Entire Ramp.
