Access Compliance Report
Public Rights-of-Way
(Curb Ramps)

Intersection ID: 42648	Main Street: JAKOBSON_DR	Cross Street: VALENDRA_DR	Location:	NW
ADA ID: E2AC805F99F7	Ramp Type: PerpDiag	Initial Pass/Fail: Fail	Overall Compliance: No	Severity Score: 21.25

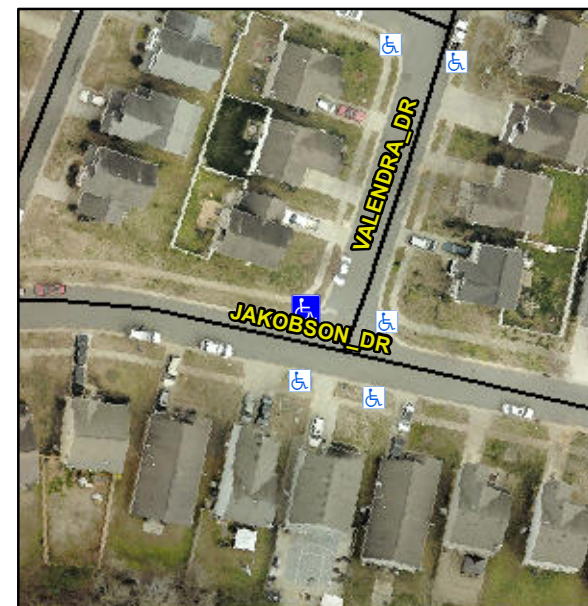
Not Found, R304.5.1, R304.5.3

Compliance	Description	Data	Compliance	Description	Data
N/A	Ramp Length (in)	82.0	Yes	Ramp Slope (%)	8.0
No	Ramp Width (in)	38.0	No	Ramp XSlope (%)	5.8
N/A	Flare Type LT	N/A	N/A	Flare Type RT	N/A
N/A	Flare Slope LT (%)	N/A	N/A	Flare Slope RT (%)	N/A
N/A	Flare Traversable LT?	N/A	N/A	Flare Traversable RT?	N/A
N/A	Landing Length (in)	N/A	N/A	DWS Provided?	N/A
N/A	Landing Width (in)	N/A	N/A	DWS Contrast?	N/A
N/A	Landing Slope (%)	N/A	N/A	DWS Length (in)	N/A
N/A	Landing X Slope (%)	N/A	N/A	DWS Full Width?	N/A
N/A	Landing Curb? (Y/N)	N/A	N/A	DWS Offset (in)	N/A
N/A	Shared Landing?	N/A			
N/A	Gutter Ponding?	N/A	N/A	Gutter Slope (%)	N/A
N/A	Gutter Lip Ht (in)	N/A	N/A	Gutter X Slope (%)	N/A
N/A	Painted X Walk1?	No	N/A	Painted X Walk2?	No
	X Walk 1 Direction	To SE		X Walk 2 Direction	To E
N/A	X Walk 1 Width (in)	N/A	N/A	X Walk 2 Width (in)	N/A
	X Walk 1 Slope (%)	6.2		X Walk 2 Slope (%)	1.9
	X Walk 1 X Slope (%)	3.6		X Walk 2 X Slope (%)	1.0

N/A	Ramp inside XWalk1?	N/A	N/A	Ramp inside XWalk2?	N/A
	Road Slope (%)	3.4	N/A	Clear Space?	N/A
	Road X Slope (%)	0.5	N/A	Clear Space to XWalk (in)	N/A
N/A	Any Obstructions?	N/A	N/A	Storm Grate/Utility Hazard?	N/A
	Obstruction Type			Storm Grate/Utility Type	
N/A					N/A
			Yes	Surface Condition? (G/P)	Good

Remove & Replace Curb Ramp With Two New Directional Ramps or Equivalent.
