Access Compliance Report
Public Rights-of-Way
(Curb Ramps)

Intersection ID: 32283	**Main Street:** MYERS_MILL_LN	**Cross Street:** LANDING_PLACE_LN	**Location:** NE
ADA ID: E3BDBD13A550	**Ramp Type:** PerpDiag	**Initial Pass/Fail:** Fail **Overall Compliance:** No	**Severity Score:** 22.5

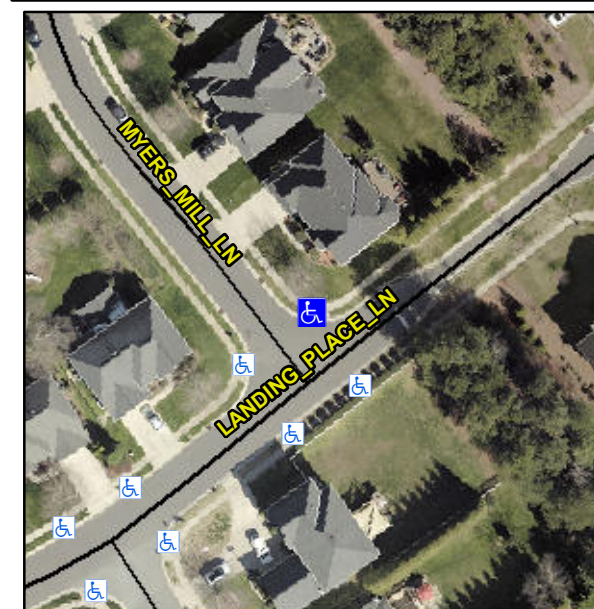
Not Found, R304.5.1, R304.2.2, R304.5.3

Compliance	Description	Data	Compliance	Description	Data
N/A	Ramp Length (in)	46.0	No	Ramp Slope (%)	8.4
No	Ramp Width (in)	47.0	No	Ramp XSlope (%)	3.5
N/A	Flare Type LT	N/A	N/A	Flare Type RT	N/A
N/A	Flare Slope LT (%)	N/A	N/A	Flare Slope RT (%)	N/A
N/A	Flare Traversable LT?	N/A	N/A	Flare Traversable RT?	N/A
N/A	Landing Length (in)	N/A	N/A	DWS Provided?	N/A
N/A	Landing Width (in)	N/A	N/A	DWS Contrast?	N/A
N/A	Landing Slope (%)	N/A	N/A	DWS Length (in)	N/A
N/A	Landing X Slope (%)	N/A	N/A	DWS Full Width?	N/A
N/A	Landing Curb? (Y/N)	N/A	N/A	DWS Offset (in)	N/A
N/A	Shared Landing?	N/A			
N/A	Gutter Ponding?	N/A	N/A	Gutter Slope (%)	N/A
N/A	Gutter Lip Ht (in)	N/A	N/A	Gutter X Slope (%)	N/A
N/A	Painted X Walk1?	No	N/A	Painted X Walk2?	No
	X Walk 1 Direction	To SW		X Walk 2 Direction	To SE
N/A	X Walk 1 Width (in)	N/A	N/A	X Walk 2 Width (in)	N/A
	X Walk 1 Slope (%)	3.8		X Walk 2 Slope (%)	1.1
	X Walk 1 X Slope (%)	1.4		X Walk 2 X Slope (%)	2.3

Remove & Replace Curb Ramp With Two New Directional Ramps or Equivalent.
