Access Compliance Report
Public Rights-of-Way
(Curb Ramps)

Intersection ID: 23917	**Main Street:** BOSHAM_LN	**Cross Street:** WHITWORTH_WY	**Location:** NE
ADA ID: E3BE3E16111C	**Ramp Type:** Perp	**Initial Pass/Fail:** Fail **Overall Compliance:** No	**Severity Score:** 10

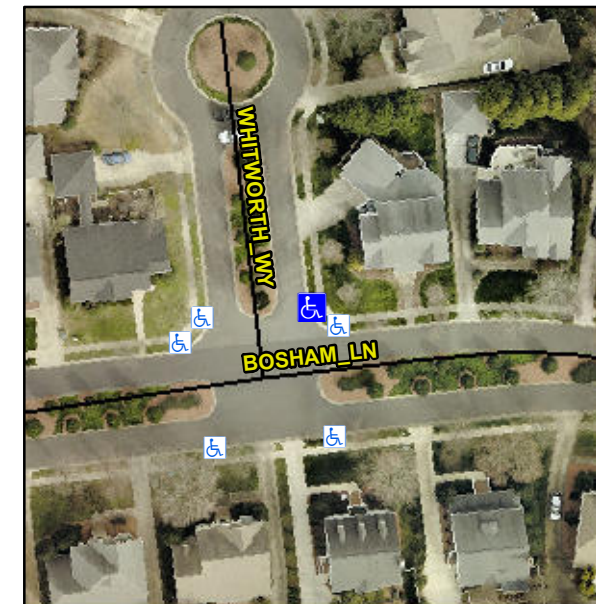
Not Found, R304.5.1, R304.5.3

Compliance	Description	Data	Compliance	Description	Data
N/A	Ramp Length (in)	47.0	Yes	Ramp Slope (%)	8.2
No	Ramp Width (in)	46.5	No	Ramp XSlope (%)	2.9
N/A	Flare Type LT	N/A	N/A	Flare Type RT	N/A
N/A	Flare Slope LT (%)	N/A	N/A	Flare Slope RT (%)	N/A
N/A	Flare Traversable LT?	N/A	N/A	Flare Traversable RT?	N/A
N/A	Landing Length (in)	N/A	N/A	DWS Provided?	N/A
N/A	Landing Width (in)	N/A	N/A	DWS Contrast?	N/A
N/A	Landing Slope (%)	N/A	N/A	DWS Length (in)	N/A
N/A	Landing X Slope (%)	N/A	N/A	DWS Full Width?	N/A
N/A	Landing Curb? (Y/N)	N/A	N/A	DWS Offset (in)	N/A
N/A	Shared Landing?	N/A			
N/A	Gutter Ponding?	N/A	N/A	Gutter Slope (%)	N/A
N/A	Gutter Lip Ht (in)	N/A	N/A	Gutter X Slope (%)	N/A
N/A	Painted X Walk1?	No	N/A	Painted X Walk2?	N/A
	X Walk 1 Direction	To W		X Walk 2 Direction	N/A
N/A	X Walk 1 Width (in)	N/A	N/A	X Walk 2 Width (in)	N/A
	X Walk 1 Slope (%)	2.9		X Walk 2 Slope (%)	N/A
	X Walk 1 X Slope (%)	1.4		X Walk 2 X Slope (%)	N/A

Remove & Replace Entire Ramp.
