Access Compliance Report
Public Rights-of-Way
(Curb Ramps)

Intersection ID: 2529	**Main Street: BAFFIN_CT**	**Cross Street: BENTGRASS_RUN_DR**	**Location: E**
ADA ID: E400B9D07434	**Ramp Type: PerpDiag**	**Initial Pass/Fail: Fail** **Overall Compliance: No**	**Severity Score: 12.5**

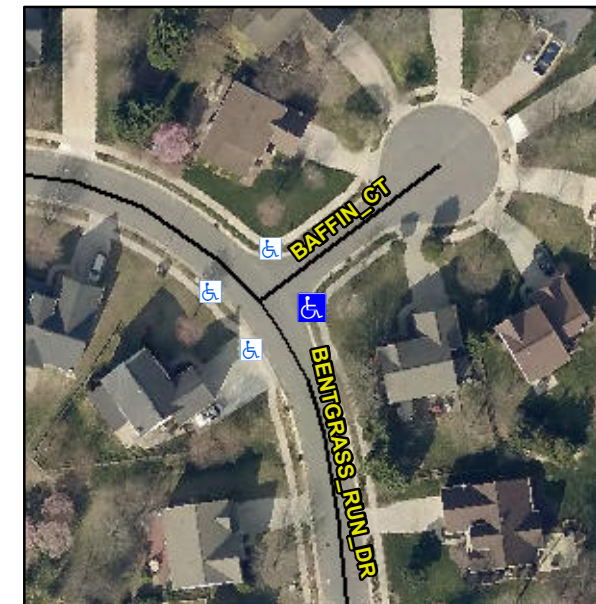
Not Found, R304.2.2

Compliance	Description	Data	Compliance	Description	Data
N/A	Ramp Length (in)	47.0	No	Ramp Slope (%)	8.9
Yes	Ramp Width (in)	48.0	Yes	Ramp XSlope (%)	0.7
N/A	Flare Type LT	N/A	N/A	Flare Type RT	N/A
N/A	Flare Slope LT (%)	N/A	N/A	Flare Slope RT (%)	N/A
N/A	Flare Traversable LT?	N/A	N/A	Flare Traversable RT?	N/A
N/A	Landing Length (in)	N/A	N/A	DWS Provided?	N/A
N/A	Landing Width (in)	N/A	N/A	DWS Contrast?	N/A
N/A	Landing Slope (%)	N/A	N/A	DWS Length (in)	N/A
N/A	Landing X Slope (%)	N/A	N/A	DWS Full Width?	N/A
N/A	Landing Curb? (Y/N)	N/A	N/A	DWS Offset (in)	N/A
N/A	Shared Landing?	N/A			
N/A	Gutter Ponding?	N/A	N/A	Gutter Slope (%)	N/A
N/A	Gutter Lip Ht (in)	N/A	N/A	Gutter X Slope (%)	N/A
N/A	Painted X Walk1?	No	N/A	Painted X Walk2?	No
	X Walk 1 Direction	To N		X Walk 2 Direction	To W
N/A	X Walk 1 Width (in)	N/A	N/A	X Walk 2 Width (in)	N/A
	X Walk 1 Slope (%)	3.1		X Walk 2 Slope (%)	2.1
	X Walk 1 X Slope (%)	2.3		X Walk 2 X Slope (%)	3.7

Remove & Replace Curb Ramp With Two New Directional Ramps or Equivalent.
