# Access Compliance Report
Public Rights-of-Way
(Curb Ramps)

Intersection ID: 6062	Main Street: BALANCING_ROCK_CT	Cross Street: SAGESTONE_CT	Location: E
ADA ID: E445AC0782C3	Ramp Type: Perp	Initial Pass/Fail: Fail	Overall Compliance: No	Severity Score: 25

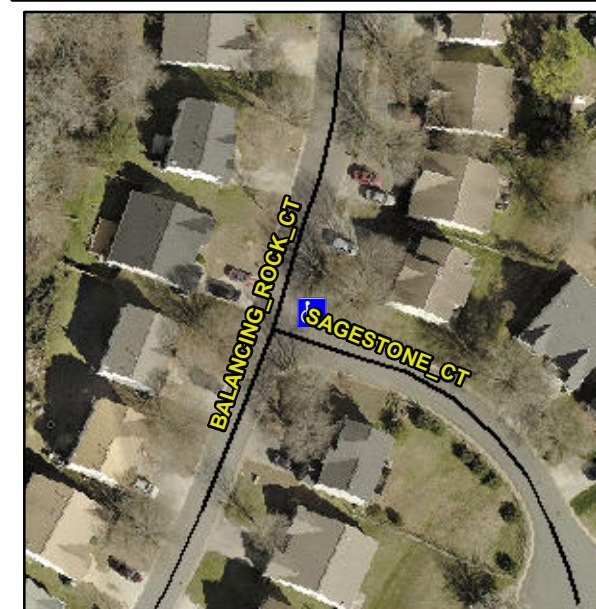
Not Found, R304.5.3

Compliance	Description	Data	Compliance	Description	Data
N/A	Ramp Length (in)	52.0	Yes	Ramp Slope (%)	5.8
Yes	Ramp Width (in)	48.0	No	Ramp XSlope (%)	12.3
N/A	Flare Type LT	N/A	N/A	Flare Type RT	N/A
N/A	Flare Slope LT (%)	N/A	N/A	Flare Slope RT (%)	N/A
N/A	Flare Traversable LT?	N/A	N/A	Flare Traversable RT?	N/A
N/A	Landing Length (in)	N/A	N/A	DWS Provided?	N/A
N/A	Landing Width (in)	N/A	N/A	DWS Contrast?	N/A
N/A	Landing Slope (%)	N/A	N/A	DWS Length (in)	N/A
N/A	Landing X Slope (%)	N/A	N/A	DWS Full Width?	N/A
N/A	Landing Curb? (Y/N)	N/A	N/A	DWS Offset (in)	N/A
N/A	Shared Landing?	N/A			
N/A	Gutter Ponding?	N/A	N/A	Gutter Slope (%)	N/A
N/A	Gutter Lip Ht (in)	1.0	N/A	Gutter X Slope (%)	N/A
N/A	Painted X Walk1?	No	N/A	Painted X Walk2?	N/A
	X Walk 1 Direction	To S		X Walk 2 Direction	N/A
N/A	X Walk 1 Width (in)	N/A	N/A	X Walk 2 Width (in)	N/A
	X Walk 1 Slope (%)	15.1		X Walk 2 Slope (%)	N/A
	X Walk 1 X Slope (%)	7.7		X Walk 2 X Slope (%)	N/A

Remove & Replace Entire Ramp.
