Access Compliance Report

# Public Rights-of-Way
(Curb Ramps)

Intersection ID: 10503	Main Street: N_GRAHAM_ST	Cross Street: PLYMOUTH_AV	Location:	SE
ADA ID: E4CF3EB5F5CA	Ramp Type: PerpDiag	Initial Pass/Fail: Fail	Overall Compliance: No	Severity Score: 12.5

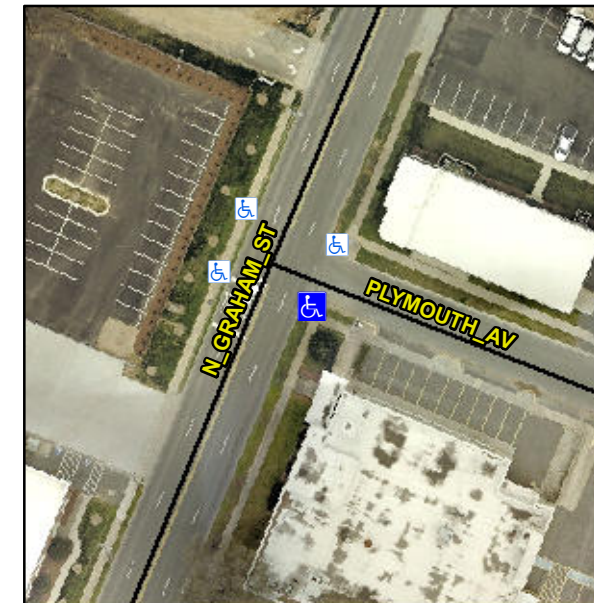
N/A

R304.2.2

Compliance	Description	Data	Compliance	Description	Data
N/A	Ramp Length (in)	74.0	No	Ramp Slope (%)	9.3
Yes	Ramp Width (in)	51.0	Yes	Ramp XSlope (%)	0.5
N/A	Flare Type LT	N/A	N/A	Flare Type RT	N/A
N/A	Flare Slope LT (%)	N/A	N/A	Flare Slope RT (%)	N/A
N/A	Flare Traversable LT?	N/A	N/A	Flare Traversable RT?	N/A
N/A	Landing Length (in)	N/A	N/A	DWS Provided?	N/A
N/A	Landing Width (in)	N/A	N/A	DWS Contrast?	N/A
N/A	Landing Slope (%)	N/A	N/A	DWS Length (in)	N/A
N/A	Landing X Slope (%)	N/A	N/A	DWS Full Width?	N/A
N/A	Landing Curb? (Y/N)	N/A	N/A	DWS Offset (in)	N/A
N/A	Shared Landing?	N/A			
N/A	Gutter Ponding?	Yes	N/A	Gutter Slope (%)	N/A
N/A	Gutter Lip Ht (in)	N/A	N/A	Gutter X Slope (%)	N/A
N/A	Painted X Walk1?	No	N/A	Painted X Walk2?	No
	X Walk 1 Direction	To NE		X Walk 2 Direction	To NW
N/A	X Walk 1 Width (in)	N/A	N/A	X Walk 2 Width (in)	N/A
	X Walk 1 Slope (%)	1.2		X Walk 2 Slope (%)	4.6
	X Walk 1 X Slope (%)	1.7		X Walk 2 X Slope (%)	0.6

Remove & Replace Curb Ramp With Two New Directional Ramps or Equivalent.
