Access Compliance Report
Public Rights-of-Way
(Curb Ramps)

Intersection ID: 2499	**Main Street:** LAGRANDE_DR	**Cross Street:** HIGHLAND_CREEK_PY	**Location:** SE
ADA ID: E4E2769F26F1	**Ramp Type:** PerpDiag	**Initial Pass/Fail:** Fail	**Overall Compliance:** No	**Severity Score:** 10

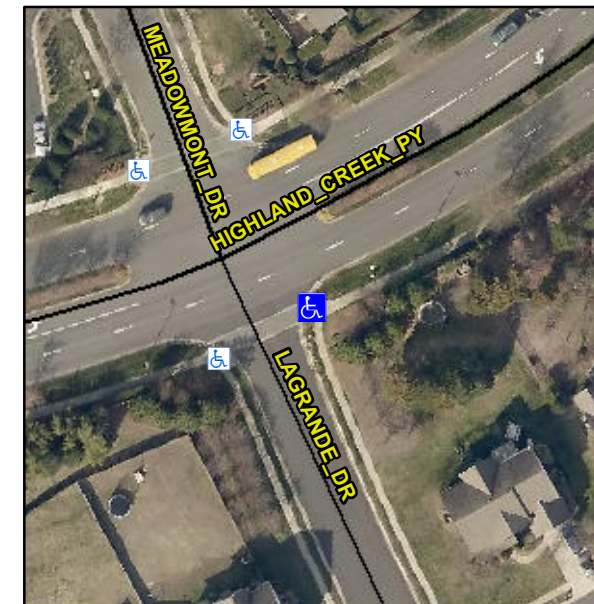
R304.5.1, R304.5.3

Compliance	**Description**	**Data**	**Compliance**	**Description**	**Data**
N/A	Ramp Length (in)	66.0	Yes	Ramp Slope (%)	7.8
No	Ramp Width (in)	38.5	No	Ramp XSlope (%)	4.1
N/A	Flare Type LT	N/A	N/A	Flare Type RT	N/A
N/A	Flare Slope LT (%)	N/A	N/A	Flare Slope RT (%)	N/A
N/A	Flare Traversable LT?	N/A	N/A	Flare Traversable RT?	N/A
N/A	Landing Length (in)	N/A	N/A	DWS Provided?	N/A
N/A	Landing Width (in)	N/A	N/A	DWS Contrast?	N/A
N/A	Landing Slope (%)	N/A	N/A	DWS Length (in)	N/A
N/A	Landing X Slope (%)	N/A	N/A	DWS Full Width?	N/A
N/A	Landing Curb? (Y/N)	N/A	N/A	DWS Offset (in)	N/A
N/A	Shared Landing?	N/A			
N/A	Gutter Ponding?	N/A	N/A	Gutter Slope (%)	N/A
N/A	Gutter Lip Ht (in)	N/A	N/A	Gutter X Slope (%)	N/A
N/A	Painted X Walk1?	No	N/A	Painted X Walk2?	Yes
	X Walk 1 Direction	To N		X Walk 2 Direction	To W
N/A	X Walk 1 Width (in)	N/A	N/A	X Walk 2 Width (in)	94.0
	X Walk 1 Slope (%)	4.6		X Walk 2 Slope (%)	0.5
	X Walk 1 X Slope (%)	1.1		X Walk 2 X Slope (%)	0.5

N/A	Ramp inside XWalk1?	N/A	N/A	Ramp inside XWalk2?	No
	Road Slope (%)	4.8	N/A	Clear Space?	N/A
	Road X Slope (%)	3.3	N/A	Clear Space to XWalk (in)	N/A
N/A	Any Obstructions?	N/A	N/A	Storm Grate/Utility Hazard?	N/A
	Obstruction Type			Storm Grate/Utility Type	
N/A					N/A
			Yes	Surface Condition? (G/P)	Good

Remove & Replace Curb Ramp With Two New Directional Ramps or Equivalent. Restripe Crosswalk.
