Access Compliance Report
Public Rights-of-Way
(Curb Ramps)

Intersection ID: 30465	Main Street: PLANTERS_ROW_DR	Cross Street: GOLDEN_VIEW_DR	Location:	S
ADA ID: E50D4DBEA6AD	Ramp Type: Directional1	Initial Pass/Fail: Fail	Overall Compliance: No	Severity Score: 25

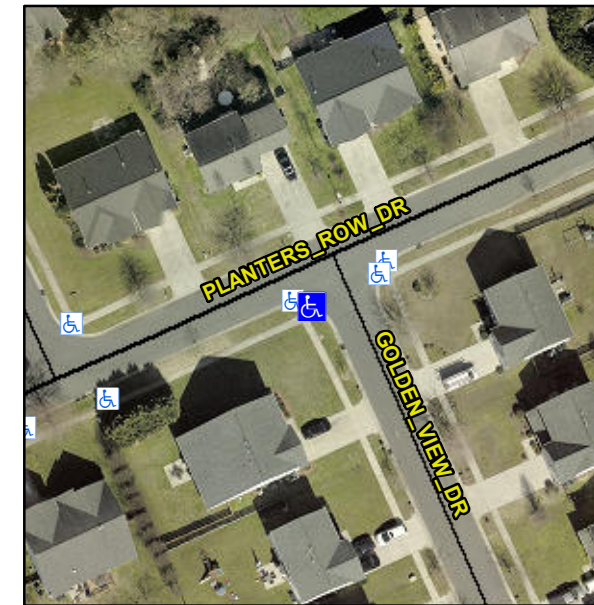
R304.5.3

Compliance	Description	Data	Compliance	Description	Data
N/A	Ramp Length (in)	36.0	N/A	Grade Break?	N/A
Yes	Ramp Width (in)	64.0	N/A	Grade Break Slope (%)	0.0
Yes	Ramp Slope (%)	2.2	N/A	Grade Break XSlope (%)	0.0
No	Ramp XSlope (%)	8.8			
N/A	Flare Type LT	N/A	N/A	Flare Type RT	N/A
N/A	Flare Slope LT (%)	N/A	N/A	Flare Slope RT (%)	0.0
N/A	Flare Traversable LT?	N/A	N/A	Flare Traversable RT?	N/A
N/A	Landing Length (in)	0.0	N/A	DWS Provided?	N/A
N/A	Landing Width (in)	0.0	N/A	DWS Contrast?	N/A
N/A	Landing Slope (%)	0.0	N/A	DWS Length (in)	N/A
N/A	Landing X Slope (%)	0.0	N/A	DWS Full Width?	N/A
N/A	Landing Curb? (Y/N)	N/A	N/A	DWS Offset LT (in)	N/A
N/A	Shared Landing?	N/A	N/A	DWS Offset RT (in)	N/A
N/A	Gutter Ponding?	0.0	N/A	Gutter Slope (%)	N/A
N/A	Gutter Lip Ht (in)	0.0	N/A	Gutter X Slope (%)	N/A
N/A	Painted X Walk1?	No		Road Slope (%)	1.3
	X Walk 1 Direction	To NE		Road X Slope (%)	2.5
	X Walk 1 Width (in)	N/A		Clear Space?	N/A

Remove & Replace Entire Ramp.
