Access Compliance Report
Public Rights-of-Way
(Curb Ramps)

Intersection ID: 13598	Main Street: W_KINGSTON_AV	Cross Street: WICKFORD_PL	Location:	S
ADA ID: E55CB0A3AFBF	Ramp Type: PerpDiag	Initial Pass/Fail: Fail	Overall Compliance: No	Severity Score: 1.25

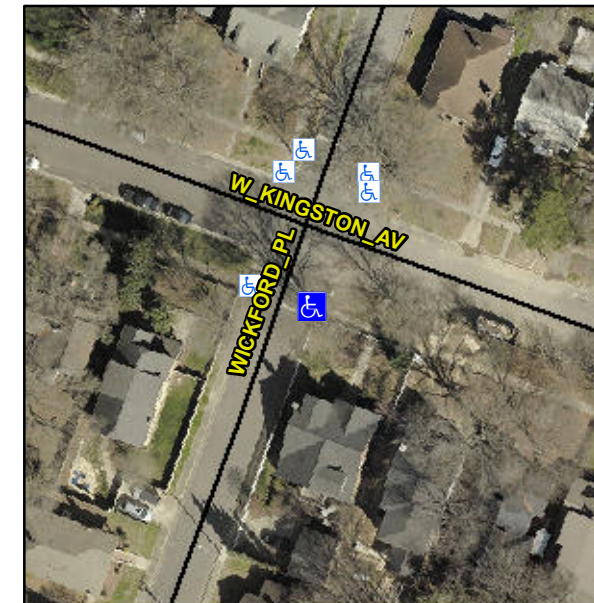
Not Found, R304.5.3

Compliance	Description	Data	Compliance	Description	Data
N/A	Ramp Length (in)	48.0	Yes	Ramp Slope (%)	6.6
Yes	Ramp Width (in)	80.0	No	Ramp XSlope (%)	2.7
N/A	Flare Type LT	N/A	N/A	Flare Type RT	N/A
N/A	Flare Slope LT (%)	N/A	N/A	Flare Slope RT (%)	N/A
N/A	Flare Traversable LT?	N/A	N/A	Flare Traversable RT?	N/A
N/A	Landing Length (in)	N/A	N/A	DWS Provided?	N/A
N/A	Landing Width (in)	N/A	N/A	DWS Contrast?	N/A
N/A	Landing Slope (%)	N/A	N/A	DWS Length (in)	N/A
N/A	Landing X Slope (%)	N/A	N/A	DWS Full Width?	N/A
N/A	Landing Curb? (Y/N)	N/A	N/A	DWS Offset (in)	N/A
N/A	Shared Landing?	N/A			
N/A	Gutter Ponding?	N/A	N/A	Gutter Slope (%)	N/A
N/A	Gutter Lip Ht (in)	N/A	N/A	Gutter X Slope (%)	N/A
N/A	Painted X Walk1?	No	N/A	Painted X Walk2?	No
	X Walk 1 Direction	To NE		X Walk 2 Direction	To NW
N/A	X Walk 1 Width (in)	N/A	N/A	X Walk 2 Width (in)	N/A
	X Walk 1 Slope (%)	0.2		X Walk 2 Slope (%)	1.2
	X Walk 1 X Slope (%)	0.6		X Walk 2 X Slope (%)	2.0

Remove & Replace Curb Ramp With Two New Directional Ramps or Equivalent.
