Access Compliance Report
Public Rights-of-Way
(Curb Ramps)

Intersection ID: 29120 **Main Street:** BEARD_RD **Cross Street:** APPLEDALE_DR **Location:** E

ADA ID: E593232E3C52 **Ramp Type:** PerpDiag **Initial Pass/Fail:** Fail **Overall Compliance:** No **Severity Score:** 22.5

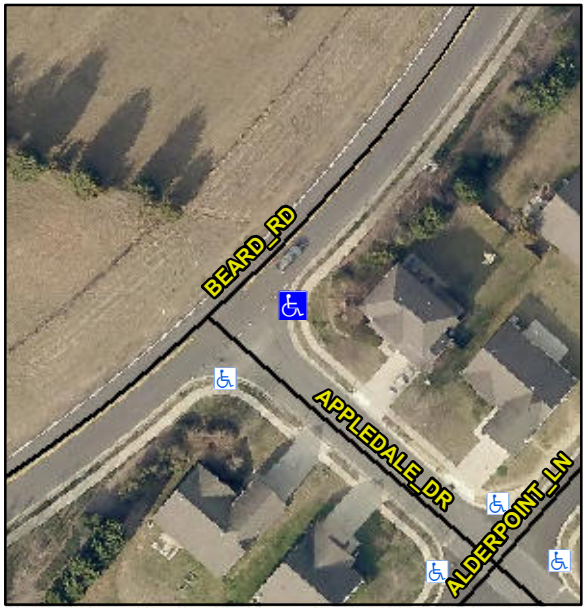
R304.5.1, R304.2.2, R304.5.3

Compliance	Description	Data	Compliance	Description	Data
N/A	Ramp Length (in)	44.0	No	Ramp Slope (%)	8.8
No	Ramp Width (in)	41.0	No	Ramp XSlope (%)	2.3
N/A	Flare Type LT	N/A	N/A	Flare Type RT	N/A
N/A	Flare Slope LT (%)	N/A	N/A	Flare Slope RT (%)	N/A
N/A	Flare Traversable LT?	N/A	N/A	Flare Traversable RT?	N/A
N/A	Landing Length (in)	N/A	N/A	DWS Provided?	N/A
N/A	Landing Width (in)	N/A	N/A	DWS Contrast?	N/A
N/A	Landing Slope (%)	N/A	N/A	DWS Length (in)	N/A
N/A	Landing X Slope (%)	N/A	N/A	DWS Full Width?	N/A
N/A	Landing Curb? (Y/N)	N/A	N/A	DWS Offset (in)	N/A
N/A	Shared Landing?	N/A			
N/A	Gutter Ponding?	N/A	N/A	Gutter Slope (%)	N/A
N/A	Gutter Lip Ht (in)	N/A	N/A	Gutter X Slope (%)	N/A
N/A	Painted X Walk1?	No	N/A	Painted X Walk2?	No
	X Walk 1 Direction	To NW		X Walk 2 Direction	To SW
N/A	X Walk 1 Width (in)	N/A	N/A	X Walk 2 Width (in)	N/A
	X Walk 1 Slope (%)	6.2		X Walk 2 Slope (%)	5.3
	X Walk 1 X Slope (%)	5.4		X Walk 2 X Slope (%)	2.7

Remove & Replace Curb Ramp With Two New Directional Ramps or Equivalent.
