# Access Compliance Report
Public Rights-of-Way
(Curb Ramps)

Intersection ID: 3992	Main Street: BENTHAVEN_LN	Cross Street: BROWNE'S_FERRY_RD	Location:	SW
ADA ID: E60C8EC4BB77	Ramp Type: Perp	Initial Pass/Fail: Pass	Overall Compliance: No	Severity Score: 10.25

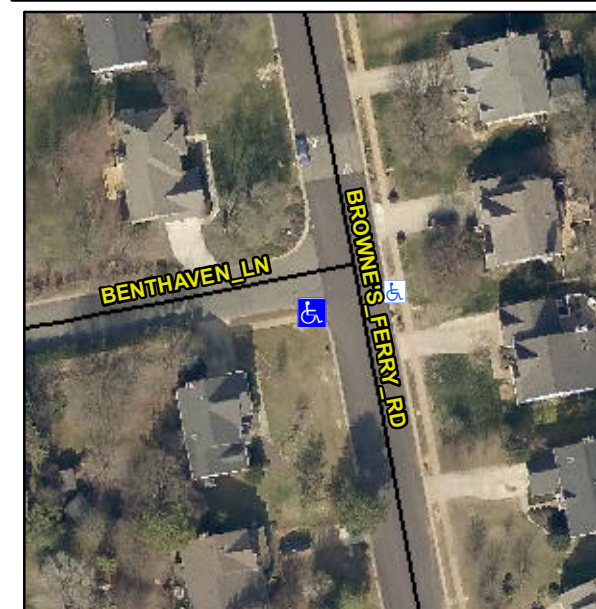
Not Found, R304.5.3, R305

Compliance	Description	Data	Compliance	Description	Data
N/A	Ramp Length (in)	32.0	Yes	Ramp Slope (%)	5.9
Yes	Ramp Width (in)	49.0	No	Ramp XSlope (%)	2.8
N/A	Flare Type LT	Sloped	N/A	Flare Type RT	N/A
N/A	Flare Slope LT (%)	8.8	N/A	Flare Slope RT (%)	4.3
N/A	Flare Traversable LT?	No	N/A	Flare Traversable RT?	No
Yes	Landing Length (in)	60.0	No	DWS Provided?	No
Yes	Landing Width (in)	49.0	N/A	DWS Contrast?	No
Yes	Landing Slope (%)	1.5	N/A	DWS Length (in)	N/A
Yes	Landing X Slope (%)	1.2	N/A	DWS Full Width?	No
N/A	Landing Curb? (Y/N)	No	N/A	DWS Offset (in)	N/A
N/A	Shared Landing?	No			
Yes	Gutter Ponding?	No	Yes	Gutter Slope (%)	1.4
Yes	Gutter Lip Ht (in)	0.0	No	Gutter X Slope (%)	3.6
N/A	Painted X Walk1?	No	N/A	Painted X Walk2?	N/A
	X Walk 1 Direction	To E		X Walk 2 Direction	N/A
N/A	X Walk 1 Width (in)	N/A	N/A	X Walk 2 Width (in)	N/A
	X Walk 1 Slope (%)	6.2		X Walk 2 Slope (%)	N/A
	X Walk 1 X Slope (%)	2.2		X Walk 2 X Slope (%)	N/A

N/A	Ramp inside XWalk1?	N/A	N/A	Ramp inside XWalk2?	N/A
	Road Slope (%)	N/A	N/A	Clear Space?	Yes
	Road X Slope (%)	N/A	N/A	Clear Space to XWalk (in)	N/A
Yes	Any Obstructions?	No	Yes	Storm Grate/Utility Hazard?	No
	Obstruction Type			Storm Grate/Utility Type	
N/A					N/A
			Yes	Surface Condition? (G/P)	Good

Remove & Replace Entire Ramp.
Remove & Replace Gutter.
