Access Compliance Report
Public Rights-of-Way
(Curb Ramps)

Intersection ID: 10025402	**Main Street:** E_BLAND_ST	**Cross Street:** N/A	**Location:** S
ADA ID: E62599867E96	**Ramp Type:** Perp	**Initial Pass/Fail:** Fail	**Overall Compliance:** No **Severity Score:** 12.5

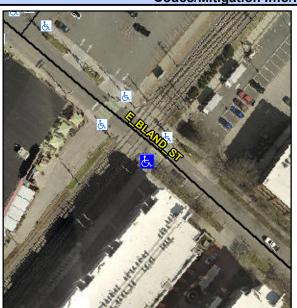
Not Found, R304.2.2

Compliance	Description	Data	Compliance	Description	Data
N/A	Ramp Length (in)	74.0	No	Ramp Slope (%)	9.7
Yes	Ramp Width (in)	136.0	Yes	Ramp XSlope (%)	0.5
N/A	Flare Type LT	N/A	N/A	Flare Type RT	N/A
N/A	Flare Slope LT (%)	N/A	N/A	Flare Slope RT (%)	N/A
N/A	Flare Traversable LT?	N/A	N/A	Flare Traversable RT?	N/A
N/A	Landing Length (in)	N/A	N/A	DWS Provided?	N/A
N/A	Landing Width (in)	N/A	N/A	DWS Contrast?	N/A
N/A	Landing Slope (%)	N/A	N/A	DWS Length (in)	N/A
N/A	Landing X Slope (%)	N/A	N/A	DWS Full Width?	N/A
N/A	Landing Curb? (Y/N)	N/A	N/A	DWS Offset (in)	N/A
N/A	Shared Landing?	N/A			
N/A	Gutter Ponding?	N/A	N/A	Gutter Slope (%)	N/A
N/A	Gutter Lip Ht (in)	N/A	N/A	Gutter X Slope (%)	N/A
N/A	Painted X Walk1?	Yes	N/A	Painted X Walk2?	N/A
	X Walk 1 Direction	To NE		X Walk 2 Direction	N/A
N/A	X Walk 1 Width (in)	172.0	N/A	X Walk 2 Width (in)	N/A
	X Walk 1 Slope (%)	0.2		X Walk 2 Slope (%)	N/A
	X Walk 1 X Slope (%)	1.2		X Walk 2 X Slope (%)	N/A

Remove & Replace Entire Ramp.
