Access Compliance Report
Public Rights-of-Way
(Curb Ramps)

Intersection ID: 9982	Main Street: E_36TH_ST	Cross Street: N_DAVIDSON_ST	Location:	E
ADA ID: E680355796FA	Ramp Type: PerpDiag	Initial Pass/Fail: Fail	Overall Compliance: No	Severity Score: 26.25

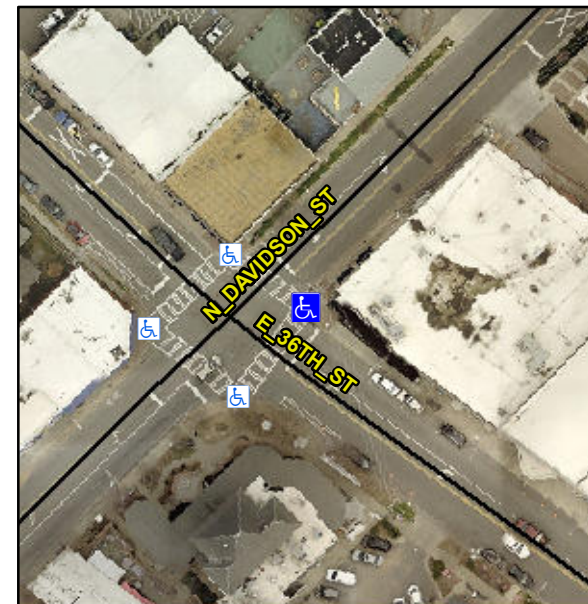
Not Found, R304.2.2, R304.5.3

Compliance	Description	Data	Compliance	Description	Data
N/A	Ramp Length (in)	80.0	No	Ramp Slope (%)	13.6
Yes	Ramp Width (in)	48.0	No	Ramp XSlope (%)	4.9
N/A	Flare Type LT	N/A	N/A	Flare Type RT	N/A
N/A	Flare Slope LT (%)	N/A	N/A	Flare Slope RT (%)	N/A
N/A	Flare Traversable LT?	N/A	N/A	Flare Traversable RT?	N/A
N/A	Landing Length (in)	N/A	N/A	DWS Provided?	N/A
N/A	Landing Width (in)	N/A	N/A	DWS Contrast?	N/A
N/A	Landing Slope (%)	N/A	N/A	DWS Length (in)	N/A
N/A	Landing X Slope (%)	N/A	N/A	DWS Full Width?	N/A
N/A	Landing Curb? (Y/N)	N/A	N/A	DWS Offset (in)	N/A
N/A	Shared Landing?	N/A			
N/A	Gutter Ponding?	N/A	N/A	Gutter Slope (%)	N/A
N/A	Gutter Lip Ht (in)	1.0	N/A	Gutter X Slope (%)	N/A
N/A	Painted X Walk1?	Yes	N/A	Painted X Walk2?	Yes
	X Walk 1 Direction	To NW		X Walk 2 Direction	To SW
N/A	X Walk 1 Width (in)	103.0	N/A	X Walk 2 Width (in)	106.0
	X Walk 1 Slope (%)	0.3		X Walk 2 Slope (%)	5.3
	X Walk 1 X Slope (%)	3.2		X Walk 2 X Slope (%)	0.3

N/A	Ramp inside XWalk1?	Yes	N/A	Ramp inside XWalk2?	Yes
	Road Slope (%)	4.0	N/A	Clear Space?	N/A
	Road X Slope (%)	3.7	N/A	Clear Space to XWalk (in)	N/A
N/A	Any Obstructions?	N/A	N/A	Storm Grate/Utility Hazard?	N/A
	Obstruction Type			Storm Grate/Utility Type	
N/A					N/A
			Yes	Surface Condition? (G/P)	Good

Remove & Replace Curb Ramp With Two New Directional Ramps or Equivalent.
