Access Compliance Report
Public Rights-of-Way
(Curb Ramps)

Intersection ID: 7479	Main Street: COTTONWOOD_ST	Cross Street: JOE_ST	Location:	NE
ADA ID: E6F2FC83DA06	Ramp Type: Perp	Initial Pass/Fail: Fail	Overall Compliance: No	Severity Score: 12.5

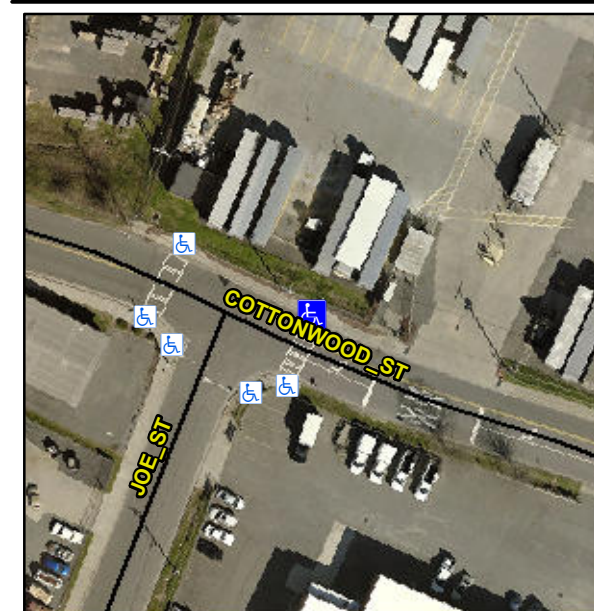
Not Found, R304.2.2

Compliance	Description	Data	Compliance	Description	Data
N/A	Ramp Length (in)	61.5	No	Ramp Slope (%)	9.1
Yes	Ramp Width (in)	53.0	Yes	Ramp XSlope (%)	0.8
N/A	Flare Type LT	N/A	N/A	Flare Type RT	N/A
N/A	Flare Slope LT (%)	N/A	N/A	Flare Slope RT (%)	N/A
N/A	Flare Traversable LT?	N/A	N/A	Flare Traversable RT?	N/A
N/A	Landing Length (in)	N/A	N/A	DWS Provided?	N/A
N/A	Landing Width (in)	N/A	N/A	DWS Contrast?	N/A
N/A	Landing Slope (%)	N/A	N/A	DWS Length (in)	N/A
N/A	Landing X Slope (%)	N/A	N/A	DWS Full Width?	N/A
N/A	Landing Curb? (Y/N)	N/A	N/A	DWS Offset (in)	N/A
N/A	Shared Landing?	N/A			
N/A	Gutter Ponding?	N/A	N/A	Gutter Slope (%)	N/A
N/A	Gutter Lip Ht (in)	N/A	N/A	Gutter X Slope (%)	N/A
N/A	Painted X Walk1?	Yes	N/A	Painted X Walk2?	N/A
	X Walk 1 Direction	To SW		X Walk 2 Direction	N/A
N/A	X Walk 1 Width (in)	112.0	N/A	X Walk 2 Width (in)	N/A
	X Walk 1 Slope (%)	6.7		X Walk 2 Slope (%)	N/A
	X Walk 1 X Slope (%)	0.0		X Walk 2 X Slope (%)	N/A

N/A	Ramp inside XWalk1?	Yes	N/A	Ramp inside XWalk2?	N/A
	Road Slope (%)	N/A	N/A	Clear Space?	N/A
	Road X Slope (%)	N/A	N/A	Clear Space to XWalk (in)	N/A
N/A	Any Obstructions?	N/A	N/A	Storm Grate/Utility Hazard?	N/A
	Obstruction Type			Storm Grate/Utility Type	
N/A					N/A
			Yes	Surface Condition? (G/P)	Good

Remove & Replace Entire Ramp.
