Access Compliance Report
Public Rights-of-Way
(Curb Ramps)

Intersection ID: 10022282	Main Street: CAMBRIDGE_BELTWAY_DR	Cross Street: N/A	Location:	N
ADA ID: E783186CBC38	Ramp Type: PerpDiag	Initial Pass/Fail: Fail	Overall Compliance: No	Severity Score: 22.5

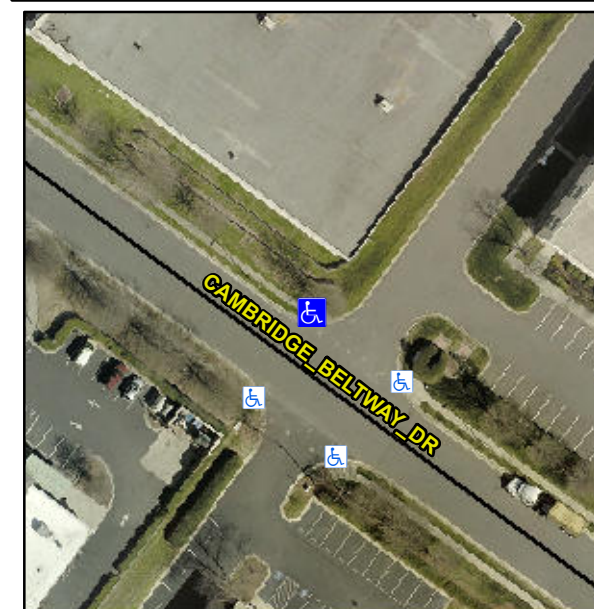
Not Found, R304.5.1, R304.2.2, R304.5.3

Compliance	Description	Data	Compliance	Description	Data
N/A	Ramp Length (in)	73.0	No	Ramp Slope (%)	10.5
No	Ramp Width (in)	37.0	No	Ramp XSlope (%)	3.5
N/A	Flare Type LT	N/A	N/A	Flare Type RT	N/A
N/A	Flare Slope LT (%)	N/A	N/A	Flare Slope RT (%)	N/A
N/A	Flare Traversable LT?	N/A	N/A	Flare Traversable RT?	N/A
N/A	Landing Length (in)	N/A	N/A	DWS Provided?	N/A
N/A	Landing Width (in)	N/A	N/A	DWS Contrast?	N/A
N/A	Landing Slope (%)	N/A	N/A	DWS Length (in)	N/A
N/A	Landing X Slope (%)	N/A	N/A	DWS Full Width?	N/A
N/A	Landing Curb? (Y/N)	N/A	N/A	DWS Offset (in)	N/A
N/A	Shared Landing?	N/A			
N/A	Gutter Ponding?	N/A	N/A	Gutter Slope (%)	N/A
N/A	Gutter Lip Ht (in)	N/A	N/A	Gutter X Slope (%)	N/A
N/A	Painted X Walk1?	No	N/A	Painted X Walk2?	No
	X Walk 1 Direction	To SW		X Walk 2 Direction	To SE
N/A	X Walk 1 Width (in)	N/A	N/A	X Walk 2 Width (in)	N/A
	X Walk 1 Slope (%)	0.3		X Walk 2 Slope (%)	1.0
	X Walk 1 X Slope (%)	1.2		X Walk 2 X Slope (%)	0.1

Remove & Replace Curb Ramp With Two New Directional Ramps or Equivalent.
