# Access Compliance Report
# Public Rights-of-Way
# (Curb Ramps)

| Intersection ID: 47300 | Main Street: LELA_AV | Cross Street: HURSTON_CR | Location: | W |
| ADA ID: E7F2F38FE330 | Ramp Type: BlendTrans1 | Initial Pass/Fail: Fail | Overall Compliance: No | Severity Score: 8.75 |

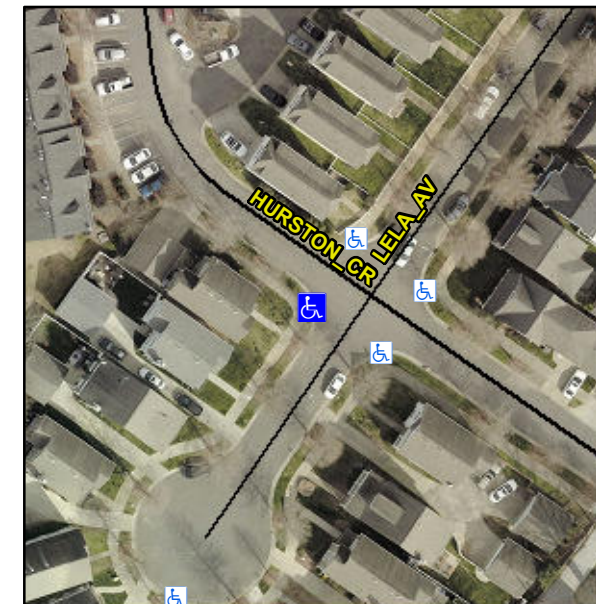
**Not Found, R304.5.1**

| Compliance | Description | Data | Compliance | Description | Data |
|---|---|---|---|---|---|
| No | Ramp Width (in) | 39.0 | Yes | BlendTrans XSlope (%) | 1.0 |
| | | | No | Curb Slope (%) | 12.1 |

**Remove & Replace Curb Ramp With Two New Directional Ramps or Equivalent.**
