Access Compliance Report
Public Rights-of-Way
(Curb Ramps)

Intersection ID: 10017066	Main Street: NEAL_RD	Cross Street: N/A	Location:	S
ADA ID: E815D239E8C6	Ramp Type: PerpDiag	Initial Pass/Fail: Fail	Overall Compliance: No	Severity Score: 67.5

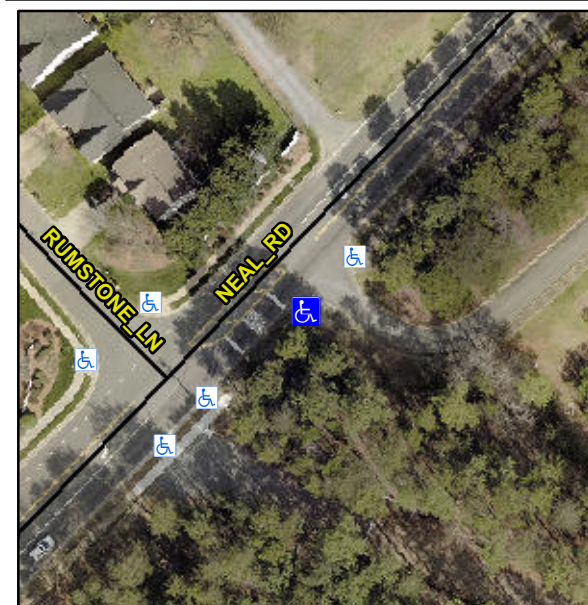
Not Found, R304.5.1, R304.2.2, R304.5.3

Compliance	Description	Data	Compliance	Description	Data
N/A	Ramp Length (in)	69.0	No	Ramp Slope (%)	12.8
No	Ramp Width (in)	34.0	No	Ramp XSlope (%)	11.7
N/A	Flare Type LT	N/A	N/A	Flare Type RT	N/A
N/A	Flare Slope LT (%)	N/A	N/A	Flare Slope RT (%)	N/A
N/A	Flare Traversable LT?	N/A	N/A	Flare Traversable RT?	N/A
N/A	Landing Length (in)	N/A	N/A	DWS Provided?	N/A
N/A	Landing Width (in)	N/A	N/A	DWS Contrast?	N/A
N/A	Landing Slope (%)	N/A	N/A	DWS Length (in)	N/A
N/A	Landing X Slope (%)	N/A	N/A	DWS Full Width?	N/A
N/A	Landing Curb? (Y/N)	N/A	N/A	DWS Offset (in)	N/A
N/A	Shared Landing?	N/A			
N/A	Gutter Ponding?	N/A	N/A	Gutter Slope (%)	N/A
N/A	Gutter Lip Ht (in)	N/A	N/A	Gutter X Slope (%)	N/A
N/A	Painted X Walk1?	No	N/A	Painted X Walk2?	No
	X Walk 1 Direction	To NE		X Walk 2 Direction	To NW
N/A	X Walk 1 Width (in)	N/A	N/A	X Walk 2 Width (in)	N/A
	X Walk 1 Slope (%)	0.2		X Walk 2 Slope (%)	8.7
	X Walk 1 X Slope (%)	6.5		X Walk 2 X Slope (%)	0.4

N/A	Ramp inside XWalk1?	N/A	N/A	Ramp inside XWalk2?	N/A
	Road Slope (%)	6.9	N/A	Clear Space?	N/A
	Road X Slope (%)	5.8	N/A	Clear Space to XWalk (in)	N/A
N/A	Any Obstructions?	N/A	N/A	Storm Grate/Utility Hazard?	N/A
	Obstruction Type			Storm Grate/Utility Type	
N/A					N/A
			Yes	Surface Condition? (G/P)	Good

Remove & Replace Curb Ramp With Two New Directional Ramps or Equivalent.
