Access Compliance Report

# Public Rights-of-Way
(Curb Ramps)

Intersection ID: 42460	**Main Street:** DUKE_LANCASTER_DR	**Cross Street:** KING_LOUIS_CT	**Location:**	**W**
ADA ID: E8A110615602	**Ramp Type:** Perp	**Initial Pass/Fail:** Fail	**Overall Compliance:** No	**Severity Score:** 35

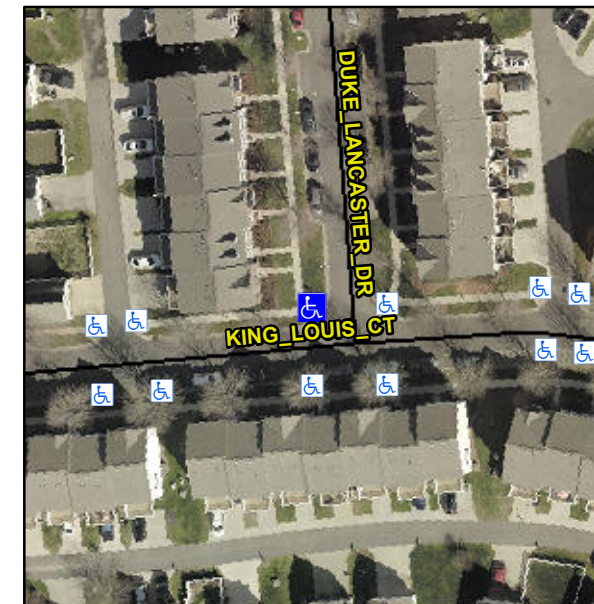
R304.5.1

Compliance	Description	Data	Compliance	Description	Data
N/A	Ramp Length (in)	47.0	Yes	Ramp Slope (%)	6.6
No	Ramp Width (in)	25.0	Yes	Ramp XSlope (%)	0.0
N/A	Flare Type LT	N/A	N/A	Flare Type RT	N/A
N/A	Flare Slope LT (%)	N/A	N/A	Flare Slope RT (%)	N/A
N/A	Flare Traversable LT?	N/A	N/A	Flare Traversable RT?	N/A
N/A	Landing Length (in)	N/A	N/A	DWS Provided?	N/A
N/A	Landing Width (in)	N/A	N/A	DWS Contrast?	N/A
N/A	Landing Slope (%)	N/A	N/A	DWS Length (in)	N/A
N/A	Landing X Slope (%)	N/A	N/A	DWS Full Width?	N/A
N/A	Landing Curb? (Y/N)	N/A	N/A	DWS Offset (in)	N/A
N/A	Shared Landing?	N/A			
N/A	Gutter Ponding?	N/A	N/A	Gutter Slope (%)	N/A
N/A	Gutter Lip Ht (in)	N/A	N/A	Gutter X Slope (%)	N/A
N/A	Painted X Walk1?	No	N/A	Painted X Walk2?	N/A
	X Walk 1 Direction	To S		X Walk 2 Direction	N/A
N/A	X Walk 1 Width (in)	N/A	N/A	X Walk 2 Width (in)	N/A
	X Walk 1 Slope (%)	0.6		X Walk 2 Slope (%)	N/A
	X Walk 1 X Slope (%)	1.0		X Walk 2 X Slope (%)	N/A

Remove & Replace Entire Ramp.
