Access Compliance Report
Public Rights-of-Way
(Curb Ramps)

Intersection ID: 44016	Main Street: ATWATER_LN	Cross Street: MANTARIO_DR	Location:	S
ADA ID: E8AB96C41D20	Ramp Type: PerpDiag	Initial Pass/Fail: Fail	Overall Compliance: No	Severity Score: 42.5

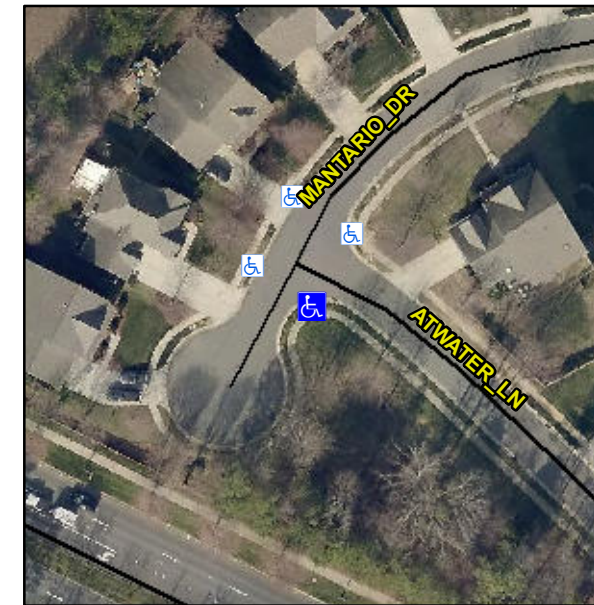
R304.5.1, R304.2.2, R304.5.3

Compliance	Description	Data	Compliance	Description	Data
N/A	Ramp Length (in)	48.0	No	Ramp Slope (%)	8.4
No	Ramp Width (in)	35.0	No	Ramp XSlope (%)	5.8
N/A	Flare Type LT	N/A	N/A	Flare Type RT	N/A
N/A	Flare Slope LT (%)	N/A	N/A	Flare Slope RT (%)	N/A
N/A	Flare Traversable LT?	N/A	N/A	Flare Traversable RT?	N/A
N/A	Landing Length (in)	N/A	N/A	DWS Provided?	N/A
N/A	Landing Width (in)	N/A	N/A	DWS Contrast?	N/A
N/A	Landing Slope (%)	N/A	N/A	DWS Length (in)	N/A
N/A	Landing X Slope (%)	N/A	N/A	DWS Full Width?	N/A
N/A	Landing Curb? (Y/N)	N/A	N/A	DWS Offset (in)	N/A
N/A	Shared Landing?	N/A			
N/A	Gutter Ponding?	N/A	N/A	Gutter Slope (%)	N/A
N/A	Gutter Lip Ht (in)	N/A	N/A	Gutter X Slope (%)	N/A
N/A	Painted X Walk1?	No	N/A	Painted X Walk2?	No
	X Walk 1 Direction	To NE		X Walk 2 Direction	To NW
N/A	X Walk 1 Width (in)	N/A	N/A	X Walk 2 Width (in)	N/A
	X Walk 1 Slope (%)	2.4		X Walk 2 Slope (%)	5.8
	X Walk 1 X Slope (%)	4.9		X Walk 2 X Slope (%)	0.8

N/A	Ramp inside XWalk1?	N/A	N/A	Ramp inside XWalk2?	N/A
	Road Slope (%)	4.3	N/A	Clear Space?	N/A
	Road X Slope (%)	3.4	N/A	Clear Space to XWalk (in)	N/A
N/A	Any Obstructions?	N/A	N/A	Storm Grate/Utility Hazard?	N/A
	Obstruction Type			Storm Grate/Utility Type	
N/A					N/A
			Yes	Surface Condition? (G/P)	Good

Remove & Replace Curb Ramp With Two New Directional Ramps or Equivalent.
