Access Compliance Report

# Public Rights-of-Way
(Curb Ramps)

Intersection ID: 5470	**Main Street: JOHN_KIRK_DR**	**Cross Street: GRADUATE_LN**	**Location: NW**
ADA ID: E8DA5C5C0E30	**Ramp Type: BlendTrans1**	**Initial Pass/Fail: Fail** **Overall Compliance: No**	**Severity Score: 10**

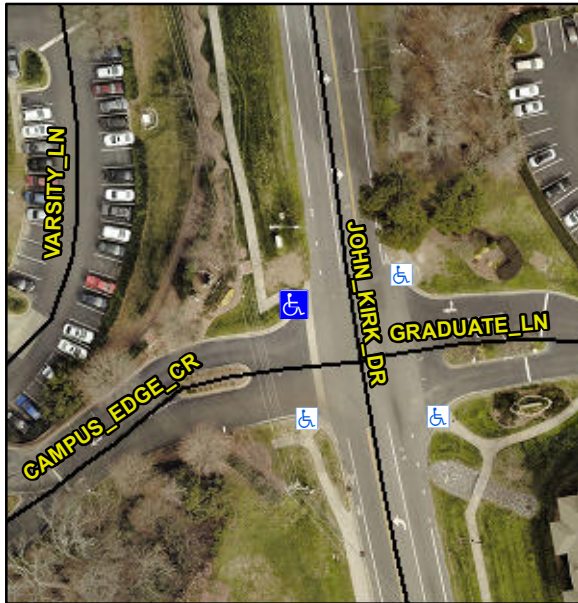
Compliance	Description	Data	Compliance	Description	Data
N/A	Ramp Length (in)	72.5	Yes	BlendTrans Slope (%)	4.2
No	Ramp Width (in)	37.0	No	BlendTrans XSlope (%)	4.0
N/A	Flare Type LT	N/A	N/A	Flare Type RT	N/A
N/A	Flare Slope LT (%)	N/A	N/A	Flare Slope RT (%)	N/A
N/A	Flare Traversable LT?	N/A	N/A	Flare Traversable RT?	N/A
N/A	Landing Length (in)	N/A	N/A	DWS Provided?	N/A
N/A	Landing Width (in)	N/A	N/A	DWS Contrast?	N/A
N/A	Landing Slope (%)	N/A	N/A	DWS Length (in)	N/A
N/A	Landing X Slope (%)	N/A	N/A	DWS Full Width?	N/A
N/A	Landing Curb? (Y/N)	N/A	N/A	DWS Offset (in)	N/A
N/A	Shared Landing?	N/A			
N/A	Gutter Ponding?	N/A	N/A	Gutter Slope (%)	N/A
N/A	Gutter Lip Ht (in)	N/A	N/A	Gutter X Slope (%)	N/A
N/A	Painted X Walk1?	No	N/A	Painted X Walk2?	No
	X Walk 1 Direction	To S		X Walk 2 Direction	To E
	X Walk 1 Width (in)	N/A		X Walk 2 Width (in)	N/A
	X Walk 1 Slope (%)	1.5		X Walk 2 Slope (%)	4.0
	X Walk 1 X Slope (%)	3.5		X Walk 2 X Slope (%)	2.7

Remove & Replace Curb Ramp With Two New Directional Ramps or Equivalent.
