Access Compliance Report
Public Rights-of-Way
(Curb Ramps)

Intersection ID: 18995	Main Street: SEACROFT_RD	Cross Street: TYVOLA_RD	Location:	SE
ADA ID: EAF31D8E0936	Ramp Type: PerpDiag	Initial Pass/Fail: Fail	Overall Compliance: No	Severity Score: 21.25

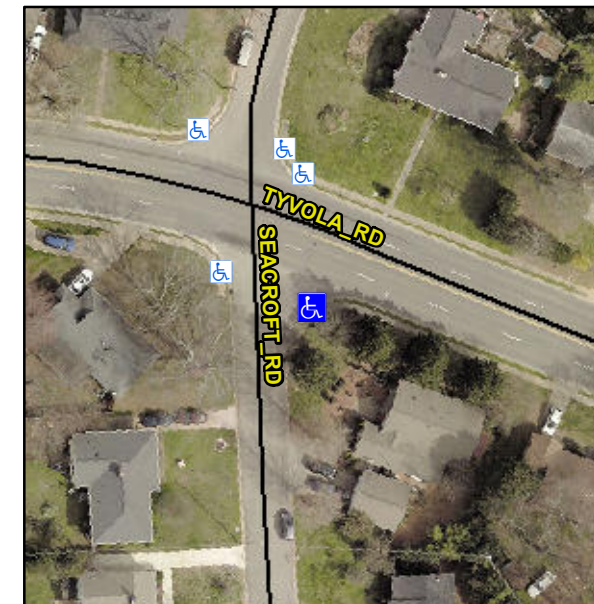
Not Found, R304.5.1, R304.5.3

Compliance	Description	Data	Compliance	Description	Data
N/A	Ramp Length (in)	60.0	Yes	Ramp Slope (%)	8.0
No	Ramp Width (in)	36.0	No	Ramp XSlope (%)	6.3
N/A	Flare Type LT	N/A	N/A	Flare Type RT	N/A
N/A	Flare Slope LT (%)	N/A	N/A	Flare Slope RT (%)	N/A
N/A	Flare Traversable LT?	N/A	N/A	Flare Traversable RT?	N/A
N/A	Landing Length (in)	N/A	N/A	DWS Provided?	N/A
N/A	Landing Width (in)	N/A	N/A	DWS Contrast?	N/A
N/A	Landing Slope (%)	N/A	N/A	DWS Length (in)	N/A
N/A	Landing X Slope (%)	N/A	N/A	DWS Full Width?	N/A
N/A	Landing Curb? (Y/N)	N/A	N/A	DWS Offset (in)	N/A
N/A	Shared Landing?	N/A			
N/A	Gutter Ponding?	N/A	N/A	Gutter Slope (%)	N/A
N/A	Gutter Lip Ht (in)	N/A	N/A	Gutter X Slope (%)	N/A
N/A	Painted X Walk1?	No	N/A	Painted X Walk2?	No
	X Walk 1 Direction	To N		X Walk 2 Direction	To NW
N/A	X Walk 1 Width (in)	N/A	N/A	X Walk 2 Width (in)	N/A
	X Walk 1 Slope (%)	2.2		X Walk 2 Slope (%)	7.1
	X Walk 1 X Slope (%)	7.0		X Walk 2 X Slope (%)	0.5

N/A	Ramp inside XWalk1?	N/A	N/A	Ramp inside XWalk2?	N/A
	Road Slope (%)	3.9	N/A	Clear Space?	N/A
	Road X Slope (%)	6.8	N/A	Clear Space to XWalk (in)	N/A
N/A	Any Obstructions?	N/A	N/A	Storm Grate/Utility Hazard?	N/A
	Obstruction Type			Storm Grate/Utility Type	
N/A					N/A
			Yes	Surface Condition? (G/P)	Good

Remove & Replace Curb Ramp With Two New Directional Ramps or Equivalent.
