Access Compliance Report
Public Rights-of-Way
(Curb Ramps)

Intersection ID: 10031487 **Main Street:** MCKEE_FOREST_CT **Cross Street:** N/A **Location:** SW

ADA ID: EDDAE145551D **Ramp Type:** BlendTrans2 **Initial Pass/Fail:** Fail **Overall Compliance:** No **Severity Score:** 12.5

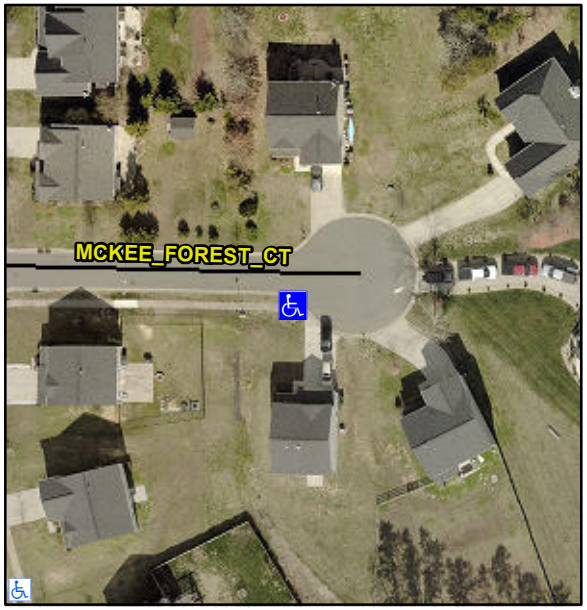
Not Found, R304.5.3

Compliance	Description	Data	Compliance	Description	Data
N/A	Ramp Length (in)	94.0	Yes	BlendTrans Slope (%)	4.8
Yes	Ramp Width (in)	48.0	No	BlendTrans XSlope (%)	5.2
N/A	Flare Type LT	N/A	N/A	Flare Type RT	N/A
N/A	Flare Slope LT (%)	N/A	N/A	Flare Slope RT (%)	N/A
N/A	Flare Traversable LT?	N/A	N/A	Flare Traversable RT?	N/A
N/A	Landing Length (in)	N/A	N/A	DWS Provided?	N/A
N/A	Landing Width (in)	N/A	N/A	DWS Contrast?	N/A
N/A	Landing Slope (%)	N/A	N/A	DWS Length (in)	N/A
N/A	Landing X Slope (%)	N/A	N/A	DWS Full Width?	N/A
N/A	Landing Curb? (Y/N)	N/A	N/A	DWS Offset (in)	N/A
N/A	Shared Landing?	N/A			
N/A	Gutter Ponding?	N/A	N/A	Gutter Slope (%)	N/A
N/A	Gutter Lip Ht (in)	N/A	N/A	Gutter X Slope (%)	N/A
N/A	Painted X Walk1?	No	N/A	Painted X Walk2?	N/A
	X Walk 1 Direction	To N		X Walk 2 Direction	N/A
	X Walk 1 Width (in)	N/A		X Walk 2 Width (in)	N/A
	X Walk 1 Slope (%)	7.8		X Walk 2 Slope (%)	N/A
	X Walk 1 X Slope (%)	6.6		X Walk 2 X Slope (%)	N/A

N/A	Ramp inside XWalk1?	N/A	N/A	Ramp inside XWalk2?	N/A
	Road Slope (%)	6.6		Clear Space?	N/A
	Road X Slope (%)	7.8	N/A	Clear Space to XWalk (in)	N/A
N/A	Any Obstructions?	N/A	N/A	Storm Grate/Utility Hazard?	N/A
	Obstruction Type			Storm Grate/Utility Type	
		N/A			N/A
			Yes	Surface Condition? (G/P)	Good
			No	Curb Slope (%)	16.5

Remove & Replace Curb Ramp With Two New Directional Ramps or Equivalent.
