Access Compliance Report
Public Rights-of-Way
(Curb Ramps)

Intersection ID: 47977	Main Street: AVALY_LN	Cross Street: SPRINGS_MILL_RD	Location:	NE
ADA ID: EDDBFBD4F16E	Ramp Type: PerpDiag	Initial Pass/Fail: Fail	Overall Compliance: No	Severity Score: 8.75

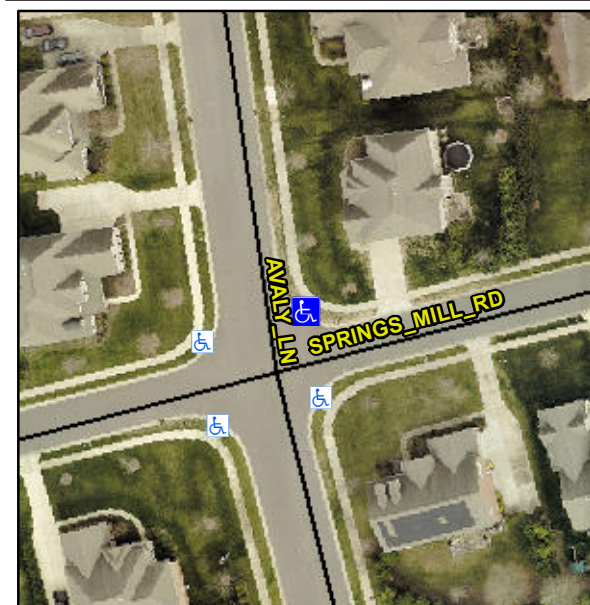
Not Found, R304.5.1

Compliance	Description	Data	Compliance	Description	Data
N/A	Ramp Length (in)	81.0	Yes	Ramp Slope (%)	5.7
No	Ramp Width (in)	39.0	Yes	Ramp XSlope (%)	0.2
N/A	Flare Type LT	N/A	N/A	Flare Type RT	N/A
N/A	Flare Slope LT (%)	N/A	N/A	Flare Slope RT (%)	N/A
N/A	Flare Traversable LT?	N/A	N/A	Flare Traversable RT?	N/A
N/A	Landing Length (in)	N/A	N/A	DWS Provided?	N/A
N/A	Landing Width (in)	N/A	N/A	DWS Contrast?	N/A
N/A	Landing Slope (%)	N/A	N/A	DWS Length (in)	N/A
N/A	Landing X Slope (%)	N/A	N/A	DWS Full Width?	N/A
N/A	Landing Curb? (Y/N)	N/A	N/A	DWS Offset (in)	N/A
N/A	Shared Landing?	N/A			
N/A	Gutter Ponding?	N/A	N/A	Gutter Slope (%)	N/A
N/A	Gutter Lip Ht (in)	N/A	N/A	Gutter X Slope (%)	N/A
N/A	Painted X Walk1?	No	N/A	Painted X Walk2?	No
	X Walk 1 Direction	To W		X Walk 2 Direction	To S
N/A	X Walk 1 Width (in)	N/A	N/A	X Walk 2 Width (in)	N/A
	X Walk 1 Slope (%)	0.5		X Walk 2 Slope (%)	0.1
	X Walk 1 X Slope (%)	2.1		X Walk 2 X Slope (%)	2.1

Remove & Replace Curb Ramp With Two New Directional Ramps or Equivalent.
