Access Compliance Report
Public Rights-of-Way
(Curb Ramps)

Intersection ID: 47361	**Main Street:** PARK_RD	**Cross Street:** N/A	**Location:** NE
ADA ID: EE93AC60676D	**Ramp Type:** Perp	**Initial Pass/Fail:** Fail	**Overall Compliance:** No **Severity Score:** 12.5

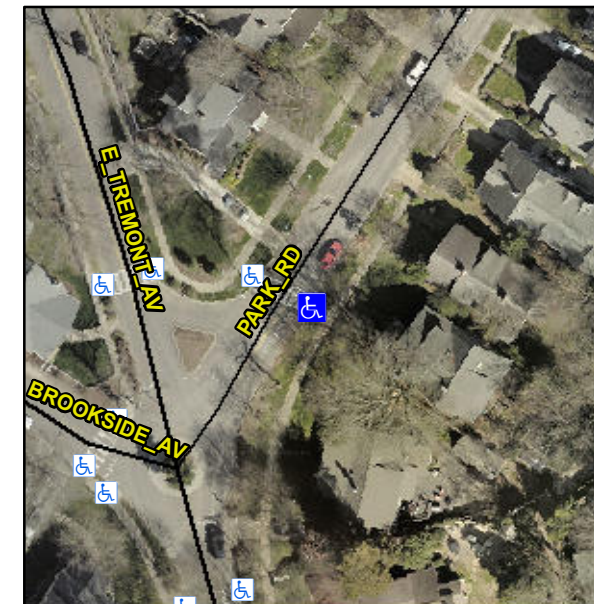
R304.2.2

Compliance	Description	Data	Compliance	Description	Data
N/A	Ramp Length (in)	106.0	No	Ramp Slope (%)	8.9
Yes	Ramp Width (in)	67.0	Yes	Ramp XSlope (%)	1.5
N/A	Flare Type LT	N/A	N/A	Flare Type RT	N/A
N/A	Flare Slope LT (%)	N/A	N/A	Flare Slope RT (%)	N/A
N/A	Flare Traversable LT?	N/A	N/A	Flare Traversable RT?	N/A
N/A	Landing Length (in)	N/A	N/A	DWS Provided?	N/A
N/A	Landing Width (in)	N/A	N/A	DWS Contrast?	N/A
N/A	Landing Slope (%)	N/A	N/A	DWS Length (in)	N/A
N/A	Landing X Slope (%)	N/A	N/A	DWS Full Width?	N/A
N/A	Landing Curb? (Y/N)	N/A	N/A	DWS Offset (in)	N/A
N/A	Shared Landing?	N/A			
N/A	Gutter Ponding?	N/A	N/A	Gutter Slope (%)	N/A
N/A	Gutter Lip Ht (in)	2.0	N/A	Gutter X Slope (%)	N/A
N/A	Painted X Walk1?	Yes	N/A	Painted X Walk2?	N/A
	X Walk 1 Direction	To NW		X Walk 2 Direction	N/A
N/A	X Walk 1 Width (in)	108.0	N/A	X Walk 2 Width (in)	N/A
	X Walk 1 Slope (%)	2.8		X Walk 2 Slope (%)	N/A
	X Walk 1 X Slope (%)	2.0		X Walk 2 X Slope (%)	N/A

Remove & Replace Entire Ramp.
