Access Compliance Report
Public Rights-of-Way
(Curb Ramps)

Intersection ID: 31509	Main Street: CARLEEN_WAY_DR	Cross Street: WILGROVE_WAY_DR	Location:	S
ADA ID: EEFC7126D828	Ramp Type: PerpDiag	Initial Pass/Fail: Fail	Overall Compliance: No	Severity Score: 30

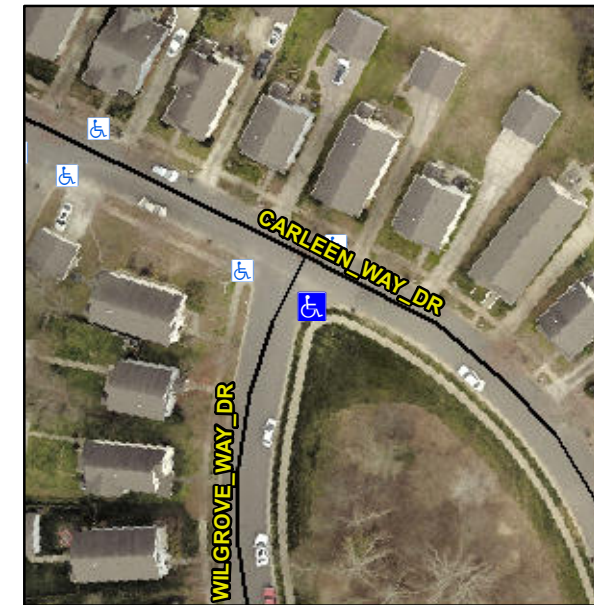
Not Found, R304.5.1, R304.2.2

Compliance	Description	Data	Compliance	Description	Data
N/A	Ramp Length (in)	45.0	No	Ramp Slope (%)	8.9
No	Ramp Width (in)	32.0	Yes	Ramp XSlope (%)	0.3
N/A	Flare Type LT	N/A	N/A	Flare Type RT	N/A
N/A	Flare Slope LT (%)	N/A	N/A	Flare Slope RT (%)	N/A
N/A	Flare Traversable LT?	N/A	N/A	Flare Traversable RT?	N/A
N/A	Landing Length (in)	N/A	N/A	DWS Provided?	N/A
N/A	Landing Width (in)	N/A	N/A	DWS Contrast?	N/A
N/A	Landing Slope (%)	N/A	N/A	DWS Length (in)	N/A
N/A	Landing X Slope (%)	N/A	N/A	DWS Full Width?	N/A
N/A	Landing Curb? (Y/N)	N/A	N/A	DWS Offset (in)	N/A
N/A	Shared Landing?	N/A			
N/A	Gutter Ponding?	N/A	N/A	Gutter Slope (%)	N/A
N/A	Gutter Lip Ht (in)	N/A	N/A	Gutter X Slope (%)	N/A
N/A	Painted X Walk1?	No	N/A	Painted X Walk2?	No
	X Walk 1 Direction	To NE		X Walk 2 Direction	To NW
N/A	X Walk 1 Width (in)	N/A	N/A	X Walk 2 Width (in)	N/A
	X Walk 1 Slope (%)	0.8		X Walk 2 Slope (%)	2.0
	X Walk 1 X Slope (%)	1.3		X Walk 2 X Slope (%)	0.1

Remove & Replace Curb Ramp With Two New Directional Ramps or Equivalent.
