Access Compliance Report
Public Rights-of-Way
(Curb Ramps)

Intersection ID: 14461	Main Street: E_WORTHINGTON_AV	Cross Street: LYNDHURST_AV	Location:	W
ADA ID: EFB3C9E3FD79	Ramp Type: Perp	Initial Pass/Fail: Fail	Overall Compliance: No	Severity Score: 25

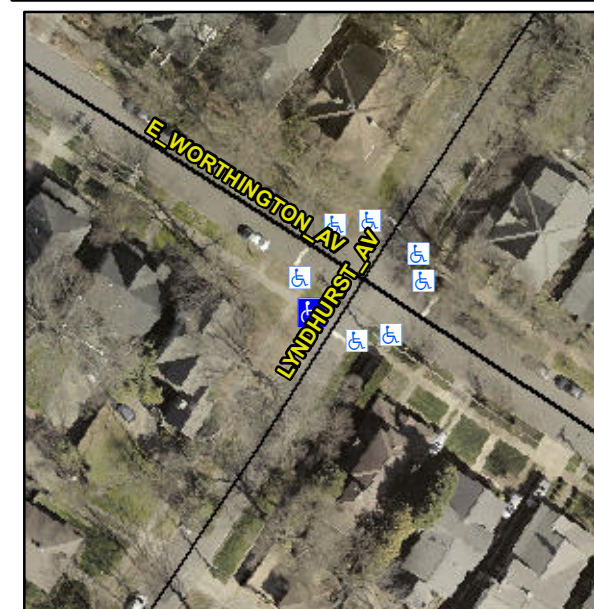
Not Found, R304.2.2, R304.5.3

Compliance	Description	Data	Compliance	Description	Data
N/A	Ramp Length (in)	66.0	No	Ramp Slope (%)	9.8
Yes	Ramp Width (in)	48.0	No	Ramp XSlope (%)	5.1
N/A	Flare Type LT	N/A	N/A	Flare Type RT	N/A
N/A	Flare Slope LT (%)	N/A	N/A	Flare Slope RT (%)	N/A
N/A	Flare Traversable LT?	N/A	N/A	Flare Traversable RT?	N/A
N/A	Landing Length (in)	N/A	N/A	DWS Provided?	N/A
N/A	Landing Width (in)	N/A	N/A	DWS Contrast?	N/A
N/A	Landing Slope (%)	N/A	N/A	DWS Length (in)	N/A
N/A	Landing X Slope (%)	N/A	N/A	DWS Full Width?	N/A
N/A	Landing Curb? (Y/N)	N/A	N/A	DWS Offset (in)	N/A
N/A	Shared Landing?	N/A			
N/A	Gutter Ponding?	N/A	N/A	Gutter Slope (%)	N/A
N/A	Gutter Lip Ht (in)	2.0	N/A	Gutter X Slope (%)	N/A
N/A	Painted X Walk1?	No	N/A	Painted X Walk2?	N/A
	X Walk 1 Direction	To SE		X Walk 2 Direction	N/A
N/A	X Walk 1 Width (in)	N/A	N/A	X Walk 2 Width (in)	N/A
	X Walk 1 Slope (%)	2.2		X Walk 2 Slope (%)	N/A
	X Walk 1 X Slope (%)	3.9		X Walk 2 X Slope (%)	N/A

Remove & Replace Entire Ramp.
