Access Compliance Report
Public Rights-of-Way
(Curb Ramps)

Intersection ID: 14409	Main Street: LABURNUM_AV	Cross Street: LORNA_ST	Location:	S
ADA ID: F035B07F4C60	Ramp Type: Perp	Initial Pass/Fail: Fail	Overall Compliance: No	Severity Score: 12.5

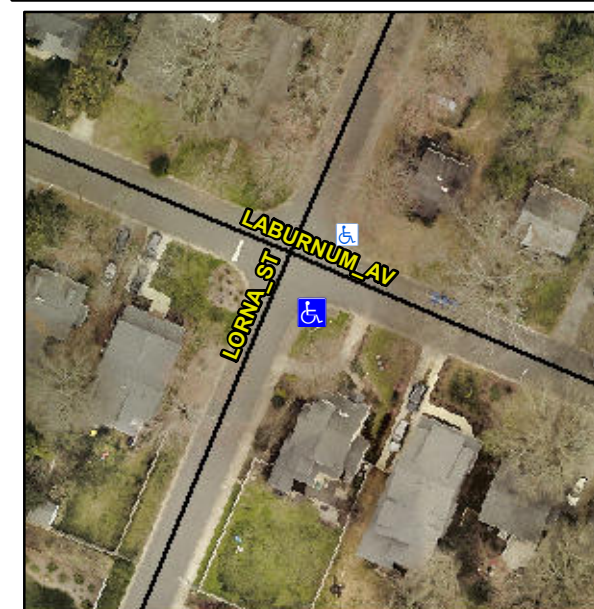
Not Found, R304.2.2

Compliance	Description	Data	Compliance	Description	Data
N/A	Ramp Length (in)	61.5	No	Ramp Slope (%)	8.4
Yes	Ramp Width (in)	48.0	Yes	Ramp XSlope (%)	0.2
N/A	Flare Type LT	N/A	N/A	Flare Type RT	N/A
N/A	Flare Slope LT (%)	N/A	N/A	Flare Slope RT (%)	N/A
N/A	Flare Traversable LT?	N/A	N/A	Flare Traversable RT?	N/A
N/A	Landing Length (in)	N/A	N/A	DWS Provided?	N/A
N/A	Landing Width (in)	N/A	N/A	DWS Contrast?	N/A
N/A	Landing Slope (%)	N/A	N/A	DWS Length (in)	N/A
N/A	Landing X Slope (%)	N/A	N/A	DWS Full Width?	N/A
N/A	Landing Curb? (Y/N)	N/A	N/A	DWS Offset (in)	N/A
N/A	Shared Landing?	N/A			
N/A	Gutter Ponding?	N/A	N/A	Gutter Slope (%)	N/A
N/A	Gutter Lip Ht (in)	N/A	N/A	Gutter X Slope (%)	N/A
N/A	Painted X Walk1?	No	N/A	Painted X Walk2?	N/A
	X Walk 1 Direction	To NE		X Walk 2 Direction	N/A
N/A	X Walk 1 Width (in)	N/A	N/A	X Walk 2 Width (in)	N/A
	X Walk 1 Slope (%)	3.8		X Walk 2 Slope (%)	N/A
	X Walk 1 X Slope (%)	2.8		X Walk 2 X Slope (%)	N/A

Remove & Replace Entire Ramp.
