Access Compliance Report
Public Rights-of-Way
(Curb Ramps)

Intersection ID: 10581	**Main Street:** ANDERSON_ST	**Cross Street:** MEADOW_LN	**Location:** SE
ADA ID: F2038374108	**Ramp Type:** Perp	**Initial Pass/Fail:** Fail **Overall Compliance:** No	**Severity Score:** 21.25

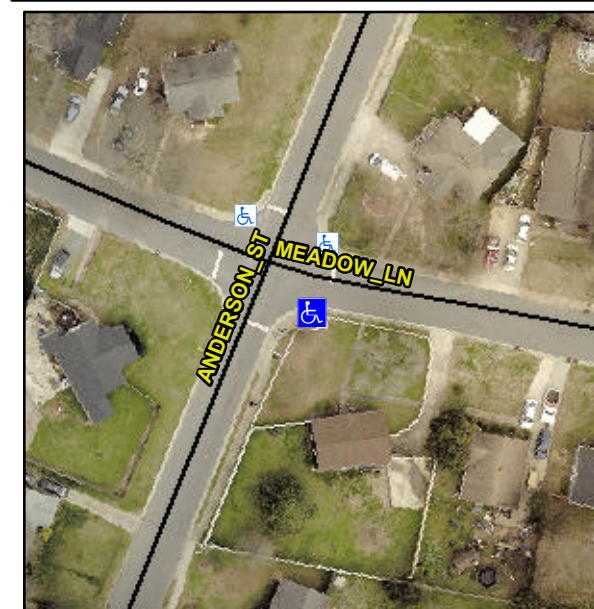
Not Found, R304.5.1, R304.5.3

Compliance	Description	Data	Compliance	Description	Data
N/A	Ramp Length (in)	89.5	Yes	Ramp Slope (%)	6.0
No	Ramp Width (in)	46.0	No	Ramp XSlope (%)	5.1
N/A	Flare Type LT	N/A	N/A	Flare Type RT	N/A
N/A	Flare Slope LT (%)	N/A	N/A	Flare Slope RT (%)	N/A
N/A	Flare Traversable LT?	N/A	N/A	Flare Traversable RT?	N/A
N/A	Landing Length (in)	N/A	N/A	DWS Provided?	N/A
N/A	Landing Width (in)	N/A	N/A	DWS Contrast?	N/A
N/A	Landing Slope (%)	N/A	N/A	DWS Length (in)	N/A
N/A	Landing X Slope (%)	N/A	N/A	DWS Full Width?	N/A
N/A	Landing Curb? (Y/N)	N/A	N/A	DWS Offset (in)	N/A
N/A	Shared Landing?	N/A			
N/A	Gutter Ponding?	N/A	N/A	Gutter Slope (%)	N/A
N/A	Gutter Lip Ht (in)	N/A	N/A	Gutter X Slope (%)	N/A
N/A	Painted X Walk1?	No	N/A	Painted X Walk2?	N/A
	X Walk 1 Direction	To NE		X Walk 2 Direction	N/A
N/A	X Walk 1 Width (in)	N/A	N/A	X Walk 2 Width (in)	N/A
	X Walk 1 Slope (%)	2.8		X Walk 2 Slope (%)	N/A
	X Walk 1 X Slope (%)	2.5		X Walk 2 X Slope (%)	N/A

Remove & Replace Entire Ramp.
