Access Compliance Report
Public Rights-of-Way
(Curb Ramps)

Intersection ID: 14629	Main Street: EASTWAY_DR	Cross Street: WOODLAND_DR	Location:	S
ADA ID: F24169131C2C	Ramp Type: PerpDiag	Initial Pass/Fail: Fail	Overall Compliance: No	Severity Score: 13.75

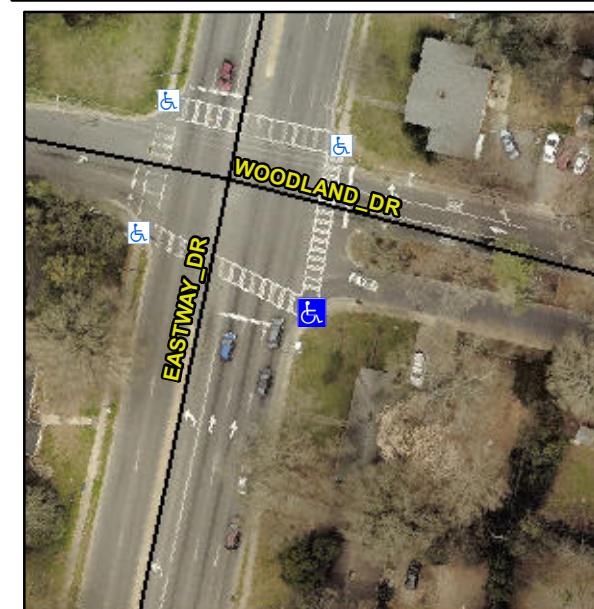
Not Found, R304.2.2, R304.5.3

Compliance	Description	Data	Compliance	Description	Data
N/A	Ramp Length (in)	59.0	No	Ramp Slope (%)	10.1
Yes	Ramp Width (in)	52.0	No	Ramp XSlope (%)	4.1
N/A	Flare Type LT	N/A	N/A	Flare Type RT	N/A
N/A	Flare Slope LT (%)	N/A	N/A	Flare Slope RT (%)	N/A
N/A	Flare Traversable LT?	N/A	N/A	Flare Traversable RT?	N/A
N/A	Landing Length (in)	N/A	N/A	DWS Provided?	N/A
N/A	Landing Width (in)	N/A	N/A	DWS Contrast?	N/A
N/A	Landing Slope (%)	N/A	N/A	DWS Length (in)	N/A
N/A	Landing X Slope (%)	N/A	N/A	DWS Full Width?	N/A
N/A	Landing Curb? (Y/N)	N/A	N/A	DWS Offset (in)	N/A
N/A	Shared Landing?	N/A			
N/A	Gutter Ponding?	N/A	N/A	Gutter Slope (%)	N/A
N/A	Gutter Lip Ht (in)	N/A	N/A	Gutter X Slope (%)	N/A
N/A	Painted X Walk1?	Yes	N/A	Painted X Walk2?	Yes
	X Walk 1 Direction	To NE		X Walk 2 Direction	To NW
N/A	X Walk 1 Width (in)	95.0	N/A	X Walk 2 Width (in)	113.0
	X Walk 1 Slope (%)	0.7		X Walk 2 Slope (%)	2.2
	X Walk 1 X Slope (%)	2.7		X Walk 2 X Slope (%)	0.6

Remove & Replace Curb Ramp With Two New Directional Ramps or Equivalent.
