Access Compliance Report
Public Rights-of-Way
(Curb Ramps)

Intersection ID: 15301	**Main Street:** E_INDEPENDENCE_BV	**Cross Street:** WESTCHESTER_BV	**Location:** NE
ADA ID: F2AFA2C0A321	**Ramp Type:** Perp	**Initial Pass/Fail:** Fail	**Overall Compliance:** No **Severity Score:** 8.75

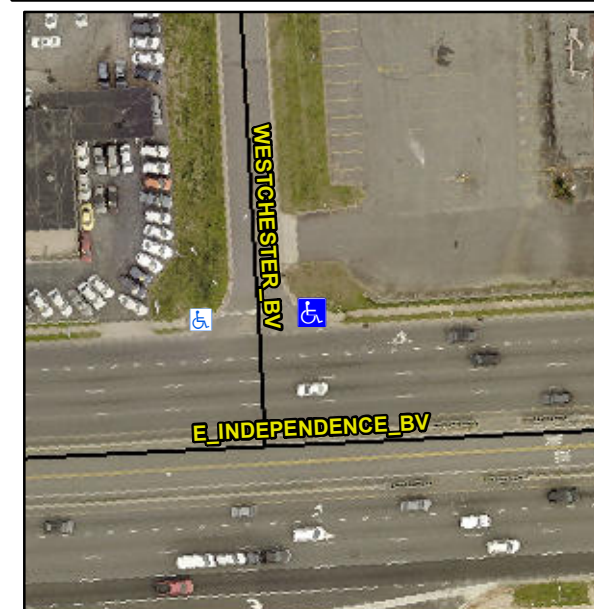
Not Found, R304.5.1

Compliance	Description	Data	Compliance	Description	Data
N/A	Ramp Length (in)	64.0	Yes	Ramp Slope (%)	6.5
No	Ramp Width (in)	40.5	Yes	Ramp XSlope (%)	1.8
N/A	Flare Type LT	N/A	N/A	Flare Type RT	N/A
N/A	Flare Slope LT (%)	N/A	N/A	Flare Slope RT (%)	N/A
N/A	Flare Traversable LT?	N/A	N/A	Flare Traversable RT?	N/A
N/A	Landing Length (in)	N/A	N/A	DWS Provided?	N/A
N/A	Landing Width (in)	N/A	N/A	DWS Contrast?	N/A
N/A	Landing Slope (%)	N/A	N/A	DWS Length (in)	N/A
N/A	Landing X Slope (%)	N/A	N/A	DWS Full Width?	N/A
N/A	Landing Curb? (Y/N)	N/A	N/A	DWS Offset (in)	N/A
N/A	Shared Landing?	N/A			
N/A	Gutter Ponding?	N/A	N/A	Gutter Slope (%)	N/A
N/A	Gutter Lip Ht (in)	N/A	N/A	Gutter X Slope (%)	N/A
N/A	Painted X Walk1?	No	N/A	Painted X Walk2?	N/A
	X Walk 1 Direction	To W		X Walk 2 Direction	N/A
N/A	X Walk 1 Width (in)	N/A	N/A	X Walk 2 Width (in)	N/A
	X Walk 1 Slope (%)	0.5		X Walk 2 Slope (%)	N/A
	X Walk 1 X Slope (%)	0.3		X Walk 2 X Slope (%)	N/A

Remove & Replace Entire Ramp.
