Access Compliance Report
Public Rights-of-Way
(Curb Ramps)

Intersection ID: 2927	Main Street: DOWNFIELD_WOOD_DR	Cross Street: RIDGEFIELD_DR	Location:	NW
ADA ID: F37C6F6B4CF5	Ramp Type: Perp	Initial Pass/Fail: Fail	Overall Compliance: No	Severity Score: 10

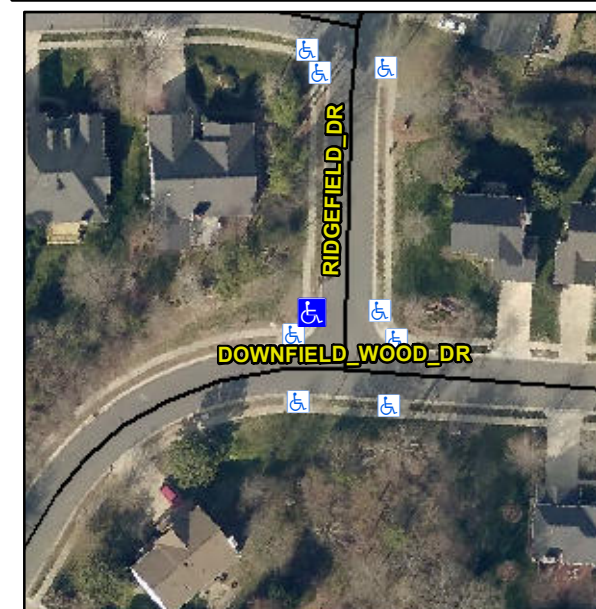
R304.5.1, R304.5.3

Compliance	Description	Data	Compliance	Description	Data
N/A	Ramp Length (in)	46.0	Yes	Ramp Slope (%)	5.1
No	Ramp Width (in)	37.0	No	Ramp XSlope (%)	2.5
N/A	Flare Type LT	N/A	N/A	Flare Type RT	N/A
N/A	Flare Slope LT (%)	N/A	N/A	Flare Slope RT (%)	N/A
N/A	Flare Traversable LT?	N/A	N/A	Flare Traversable RT?	N/A
N/A	Landing Length (in)	N/A	N/A	DWS Provided?	N/A
N/A	Landing Width (in)	N/A	N/A	DWS Contrast?	N/A
N/A	Landing Slope (%)	N/A	N/A	DWS Length (in)	N/A
N/A	Landing X Slope (%)	N/A	N/A	DWS Full Width?	N/A
N/A	Landing Curb? (Y/N)	N/A	N/A	DWS Offset (in)	N/A
N/A	Shared Landing?	N/A			
N/A	Gutter Ponding?	N/A	N/A	Gutter Slope (%)	N/A
N/A	Gutter Lip Ht (in)	N/A	N/A	Gutter X Slope (%)	N/A
N/A	Painted X Walk1?	No	N/A	Painted X Walk2?	N/A
	X Walk 1 Direction	To E		X Walk 2 Direction	N/A
N/A	X Walk 1 Width (in)	N/A	N/A	X Walk 2 Width (in)	N/A
	X Walk 1 Slope (%)	1.5		X Walk 2 Slope (%)	N/A
	X Walk 1 X Slope (%)	2.8		X Walk 2 X Slope (%)	N/A

Remove & Replace Entire Ramp.
