Access Compliance Report
Public Rights-of-Way
(Curb Ramps)

Intersection ID: 3220	**Main Street:** MEADOW_POST_LN	**Cross Street:** OLD_TIMBER_RD	**Location:** SW
ADA ID: F448874D782B	**Ramp Type:** Perp	**Initial Pass/Fail:** Fail	**Overall Compliance:** No **Severity Score:** 21.25

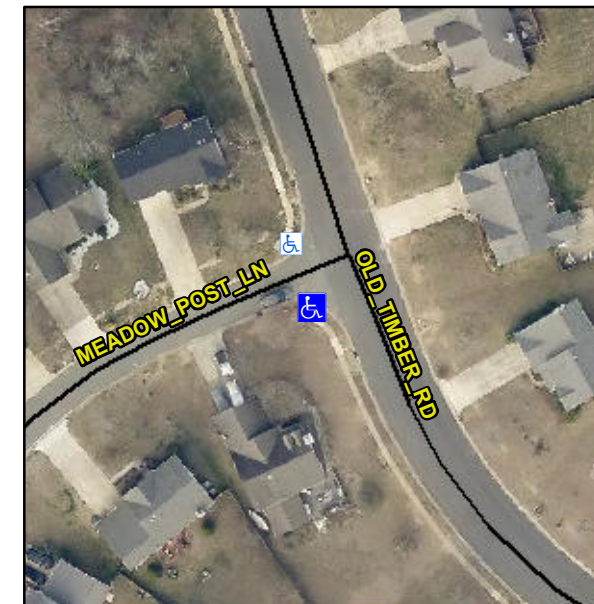
Not Found, R304.5.1, R304.2.2

Compliance	Description	Data	Compliance	Description	Data
N/A	Ramp Length (in)	46.5	No	Ramp Slope (%)	11.1
No	Ramp Width (in)	46.0	Yes	Ramp XSlope (%)	0.4
N/A	Flare Type LT	N/A	N/A	Flare Type RT	N/A
N/A	Flare Slope LT (%)	N/A	N/A	Flare Slope RT (%)	N/A
N/A	Flare Traversable LT?	N/A	N/A	Flare Traversable RT?	N/A
N/A	Landing Length (in)	N/A	N/A	DWS Provided?	N/A
N/A	Landing Width (in)	N/A	N/A	DWS Contrast?	N/A
N/A	Landing Slope (%)	N/A	N/A	DWS Length (in)	N/A
N/A	Landing X Slope (%)	N/A	N/A	DWS Full Width?	N/A
N/A	Landing Curb? (Y/N)	N/A	N/A	DWS Offset (in)	N/A
N/A	Shared Landing?	N/A			
N/A	Gutter Ponding?	N/A	N/A	Gutter Slope (%)	N/A
N/A	Gutter Lip Ht (in)	N/A	N/A	Gutter X Slope (%)	N/A
N/A	Painted X Walk1?	No	N/A	Painted X Walk2?	N/A
	X Walk 1 Direction	To N		X Walk 2 Direction	N/A
N/A	X Walk 1 Width (in)	N/A	N/A	X Walk 2 Width (in)	N/A
	X Walk 1 Slope (%)	2.7		X Walk 2 Slope (%)	N/A
	X Walk 1 X Slope (%)	0.1		X Walk 2 X Slope (%)	N/A

Remove & Replace Entire Ramp.
