Access Compliance Report
Public Rights-of-Way
(Curb Ramps)

Intersection ID: 10028581 **Main Street:** HOLYOKE_LN **Cross Street:** N/A **Location:** W

ADA ID: F4D3F1D504A6 **Ramp Type:** Perp **Initial Pass/Fail:** Fail **Overall Compliance:** No **Severity Score:** 25

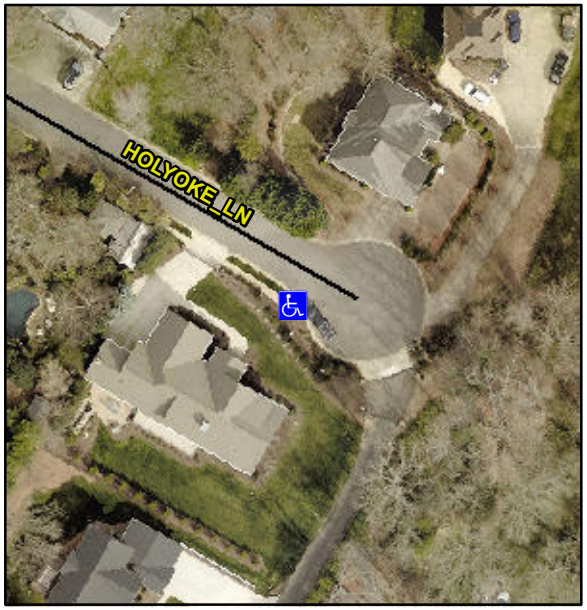
Not Found, R304.5.3

Compliance	Description	Data	Compliance	Description	Data
N/A	Ramp Length (in)	48.0	Yes	Ramp Slope (%)	8.3
Yes	Ramp Width (in)	48.0	No	Ramp XSlope (%)	8.5
N/A	Flare Type LT	N/A	N/A	Flare Type RT	N/A
N/A	Flare Slope LT (%)	N/A	N/A	Flare Slope RT (%)	N/A
N/A	Flare Traversable LT?	N/A	N/A	Flare Traversable RT?	N/A
N/A	Landing Length (in)	N/A	N/A	DWS Provided?	N/A
N/A	Landing Width (in)	N/A	N/A	DWS Contrast?	N/A
N/A	Landing Slope (%)	N/A	N/A	DWS Length (in)	N/A
N/A	Landing X Slope (%)	N/A	N/A	DWS Full Width?	N/A
N/A	Landing Curb? (Y/N)	N/A	N/A	DWS Offset (in)	N/A
N/A	Shared Landing?	N/A			
N/A	Gutter Ponding?	N/A	N/A	Gutter Slope (%)	N/A
N/A	Gutter Lip Ht (in)	N/A	N/A	Gutter X Slope (%)	N/A
N/A	Painted X Walk1?	No	N/A	Painted X Walk2?	N/A
	X Walk 1 Direction	To E		X Walk 2 Direction	N/A
N/A	X Walk 1 Width (in)	N/A	N/A	X Walk 2 Width (in)	N/A
	X Walk 1 Slope (%)	4.3		X Walk 2 Slope (%)	N/A
	X Walk 1 X Slope (%)	8.2		X Walk 2 X Slope (%)	N/A

Remove & Replace Entire Ramp.
