Access Compliance Report
Public Rights-of-Way
(Curb Ramps)

Intersection ID: 13487	**Main Street:** S_MINT_ST	**Cross Street:** W_KINGSTON_AV	**Location:** N
ADA ID: F6D9EB7EF0BF	**Ramp Type:** Perp	**Initial Pass/Fail:** Fail	**Overall Compliance:** No	**Severity Score:** 8.75

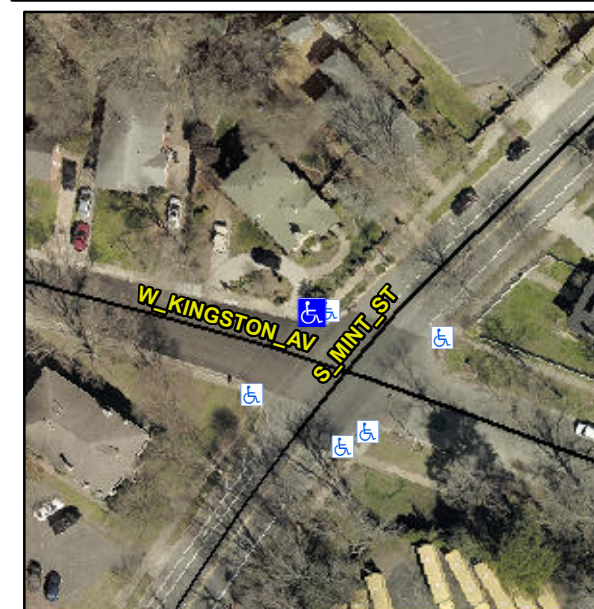
Not Found, R304.5.1

Compliance	Description	Data	Compliance	Description	Data
N/A	Ramp Length (in)	48.0	Yes	Ramp Slope (%)	6.4
No	Ramp Width (in)	40.0	Yes	Ramp XSlope (%)	0.1
N/A	Flare Type LT	N/A	N/A	Flare Type RT	N/A
N/A	Flare Slope LT (%)	N/A	N/A	Flare Slope RT (%)	N/A
N/A	Flare Traversable LT?	N/A	N/A	Flare Traversable RT?	N/A
N/A	Landing Length (in)	N/A	N/A	DWS Provided?	N/A
N/A	Landing Width (in)	N/A	N/A	DWS Contrast?	N/A
N/A	Landing Slope (%)	N/A	N/A	DWS Length (in)	N/A
N/A	Landing X Slope (%)	N/A	N/A	DWS Full Width?	N/A
N/A	Landing Curb? (Y/N)	N/A	N/A	DWS Offset (in)	N/A
N/A	Shared Landing?	N/A			
N/A	Gutter Ponding?	N/A	N/A	Gutter Slope (%)	N/A
N/A	Gutter Lip Ht (in)	N/A	N/A	Gutter X Slope (%)	N/A
N/A	Painted X Walk1?	No	N/A	Painted X Walk2?	N/A
	X Walk 1 Direction	To SW		X Walk 2 Direction	N/A
N/A	X Walk 1 Width (in)	N/A	N/A	X Walk 2 Width (in)	N/A
	X Walk 1 Slope (%)	0.8		X Walk 2 Slope (%)	N/A
	X Walk 1 X Slope (%)	1.1		X Walk 2 X Slope (%)	N/A

Remove & Replace Entire Ramp.
