Access Compliance Report
Public Rights-of-Way
(Curb Ramps)

Intersection ID: 5264 | **Main Street:** BEATTIES_FORD_RD | **Cross Street:** MCINTYRE_AV | **Location:** NW

ADA ID: F6DF44C0611A | **Ramp Type:** Directional1 | **Initial Pass/Fail:** Pass | **Overall Compliance:** No | **Severity Score:** 7.75

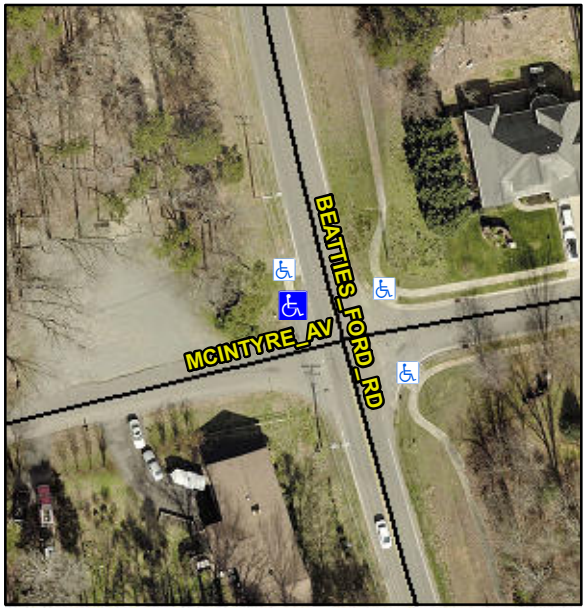
NO CURB

R304.5.3, R305.1.4, R305.2, R304.5.4

Remove & Replace Entire Ramp.
Remove & Replace Gutter.
