Access Compliance Report
Public Rights-of-Way
(Curb Ramps)

Intersection ID: N/A | **Main Street:** PROVIDENCE_RD | **Cross Street:** BERKELEY_GREENE_DR | **Location:** W

ADA ID: F98AE74A588B | **Ramp Type:** PerpDiag | **Initial Pass/Fail:** Fail | **Overall Compliance:** No | **Severity Score:** 13.75

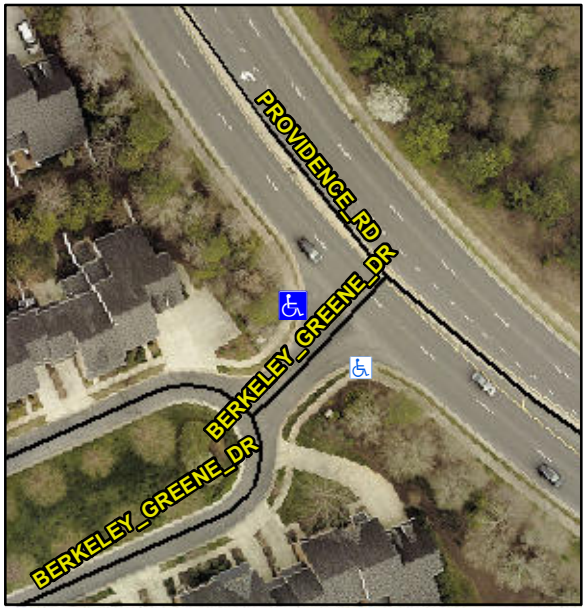
R304.2.2, R304.5.3

Remove & Replace Curb Ramp With Two New Directional Ramps or Equivalent.

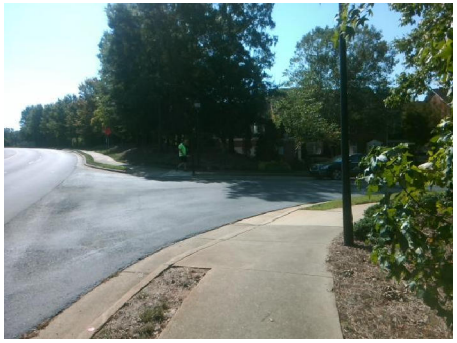
Compliance	Description	Data	Compliance	Description	Data
N/A	Ramp Length (in)	71.0	No	Ramp Slope (%)	8.7
Yes	Ramp Width (in)	49.0	No	Ramp XSlope (%)	3.9
N/A	Flare Type LT	N/A	N/A	Flare Type RT	N/A
N/A	Flare Slope LT (%)	N/A	N/A	Flare Slope RT (%)	N/A
N/A	Flare Traversable LT?	N/A	N/A	Flare Traversable RT?	N/A
N/A	Landing Length (in)	N/A	N/A	DWS Provided?	N/A
N/A	Landing Width (in)	N/A	N/A	DWS Contrast?	N/A
N/A	Landing Slope (%)	N/A	N/A	DWS Length (in)	N/A
N/A	Landing X Slope (%)	N/A	N/A	DWS Full Width?	N/A
N/A	Landing Curb? (Y/N)	N/A	N/A	DWS Offset (in)	N/A
N/A	Shared Landing?	N/A			
N/A	Gutter Ponding?	N/A	N/A	Gutter Slope (%)	N/A
N/A	Gutter Lip Ht (in)	N/A	N/A	Gutter X Slope (%)	N/A
N/A	Painted X Walk1?	No	N/A	Painted X Walk2?	No
	X Walk 1 Direction	To SE		X Walk 2 Direction	To NE
N/A	X Walk 1 Width (in)	N/A	N/A	X Walk 2 Width (in)	N/A
	X Walk 1 Slope (%)	5.2		X Walk 2 Slope (%)	0.9

X Walk 1 X Slope (%)	2.0		X Walk 2 X Slope (%)	4.0
N/A	Ramp inside XWalk1?	N/A	N/A	Ramp inside XWalk2?	N/A
	Road Slope (%)	0.7	N/A	Clear Space?	N/A
	Road X Slope (%)	3.8	N/A	Clear Space to XWalk (in)	N/A
N/A	Any Obstructions?	N/A	N/A	Storm Grate/Utility Hazard?	N/A
	Obstruction Type			Storm Grate/Utility Type	
		N/A			N/A
			Yes	Surface Condition? (G/P)	Good
