Access Compliance Report
Public Rights-of-Way
(Curb Ramps)

Intersection ID: N/A | **Main Street:** YORK_CENTER | **Cross Street:** N/A | **Location:** NE

ADA ID: F9903D412123 | **Ramp Type:** Perp | **Initial Pass/Fail:** Fail | **Overall Compliance:** No | **Severity Score:** 22.5

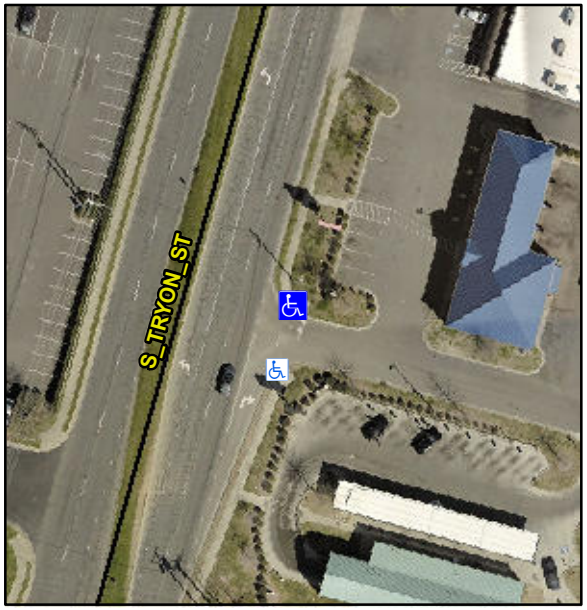
Not Found, R304.5.1, R304.2.2, R304.5.3

Compliance	Description	Data	Compliance	Description	Data
N/A	Ramp Length (in)	91.5	No	Ramp Slope (%)	9.3
No	Ramp Width (in)	47.0	No	Ramp XSlope (%)	2.4
N/A	Flare Type LT	N/A	N/A	Flare Type RT	N/A
N/A	Flare Slope LT (%)	N/A	N/A	Flare Slope RT (%)	N/A
N/A	Flare Traversable LT?	N/A	N/A	Flare Traversable RT?	N/A
N/A	Landing Length (in)	N/A	N/A	DWS Provided?	N/A
N/A	Landing Width (in)	N/A	N/A	DWS Contrast?	N/A
N/A	Landing Slope (%)	N/A	N/A	DWS Length (in)	N/A
N/A	Landing X Slope (%)	N/A	N/A	DWS Full Width?	N/A
N/A	Landing Curb? (Y/N)	N/A	N/A	DWS Offset (in)	N/A
N/A	Shared Landing?	N/A			
N/A	Gutter Ponding?	N/A	N/A	Gutter Slope (%)	N/A
N/A	Gutter Lip Ht (in)	N/A	N/A	Gutter X Slope (%)	N/A
N/A	Painted X Walk1?	Yes	N/A	Painted X Walk2?	N/A
	X Walk 1 Direction	To S		X Walk 2 Direction	N/A
N/A	X Walk 1 Width (in)	54.0	N/A	X Walk 2 Width (in)	N/A
	X Walk 1 Slope (%)	0.9		X Walk 2 Slope (%)	N/A
	X Walk 1 X Slope (%)	0.1		X Walk 2 X Slope (%)	N/A

Remove & Replace Entire Ramp.
