Access Compliance Report
Public Rights-of-Way
(Curb Ramps)

Intersection ID: 29180	Main Street: BOXELDER_LN	Cross Street: BIG_LEAF_DR	Location:	NE
ADA ID: F9E15F5C27EB	Ramp Type: PerpDiag	Initial Pass/Fail: Fail	Overall Compliance: No	Severity Score: 10

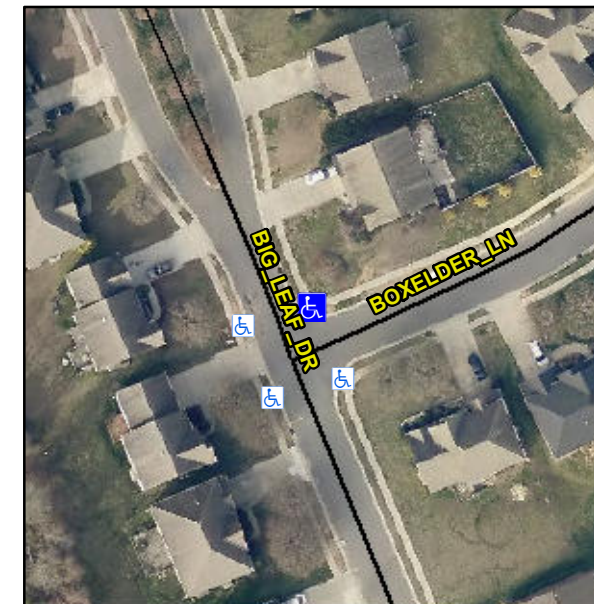
Not Found, R304.5.1, R304.5.3

Compliance	Description	Data	Compliance	Description	Data
N/A	Ramp Length (in)	47.0	Yes	Ramp Slope (%)	6.4
No	Ramp Width (in)	41.5	No	Ramp XSlope (%)	2.3
N/A	Flare Type LT	N/A	N/A	Flare Type RT	N/A
N/A	Flare Slope LT (%)	N/A	N/A	Flare Slope RT (%)	N/A
N/A	Flare Traversable LT?	N/A	N/A	Flare Traversable RT?	N/A
N/A	Landing Length (in)	N/A	N/A	DWS Provided?	N/A
N/A	Landing Width (in)	N/A	N/A	DWS Contrast?	N/A
N/A	Landing Slope (%)	N/A	N/A	DWS Length (in)	N/A
N/A	Landing X Slope (%)	N/A	N/A	DWS Full Width?	N/A
N/A	Landing Curb? (Y/N)	N/A	N/A	DWS Offset (in)	N/A
N/A	Shared Landing?	N/A			
N/A	Gutter Ponding?	N/A	N/A	Gutter Slope (%)	N/A
N/A	Gutter Lip Ht (in)	N/A	N/A	Gutter X Slope (%)	N/A
N/A	Painted X Walk1?	No	N/A	Painted X Walk2?	No
	X Walk 1 Direction	To W		X Walk 2 Direction	To S
N/A	X Walk 1 Width (in)	N/A	N/A	X Walk 2 Width (in)	N/A
	X Walk 1 Slope (%)	5.5		X Walk 2 Slope (%)	0.1
	X Walk 1 X Slope (%)	0.2		X Walk 2 X Slope (%)	1.8

Remove & Replace Curb Ramp With Two New Directional Ramps or Equivalent.
